## Owner Builder Warranty Inspection Report (137B)

Inspection Date: Mon, 3 Oct 2022

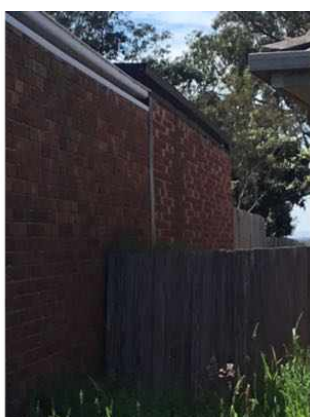
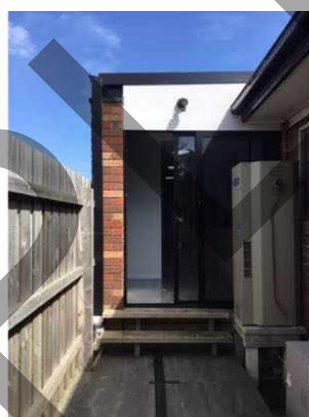
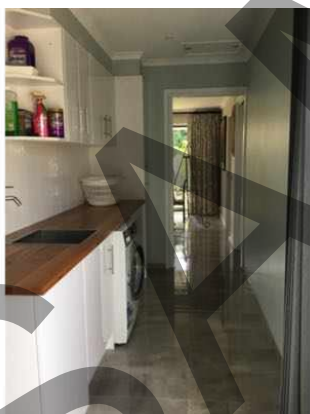
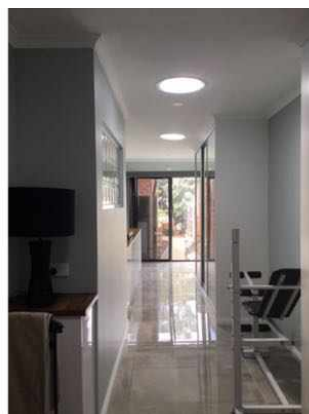
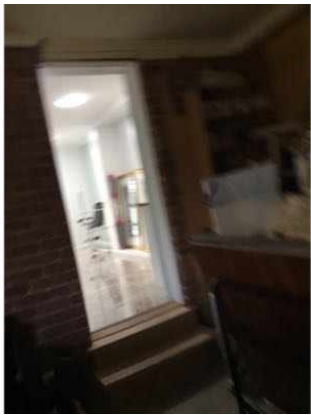
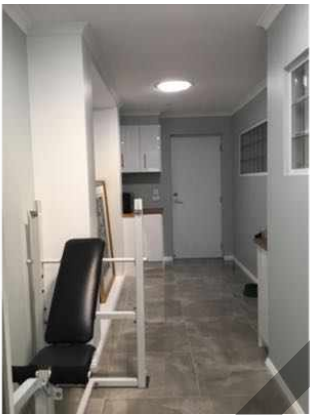
- The hallway laundry additions were completed under a building permit issued by Combined Building Consultants. These works are still in good condition with no defects at the time of the inspection.

Building: Building 1  
Location: Hallway  
Finding: No works required  
Information: No remedial works are required at the current time. Works have been completed to an acceptable level and do not pose any defects at the time of inspection. These works were subject to a building permit.

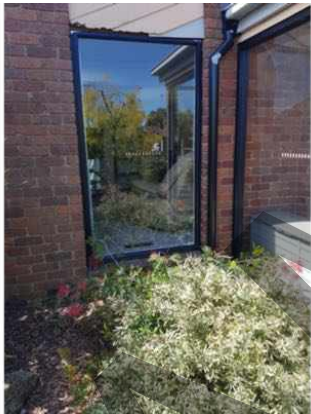
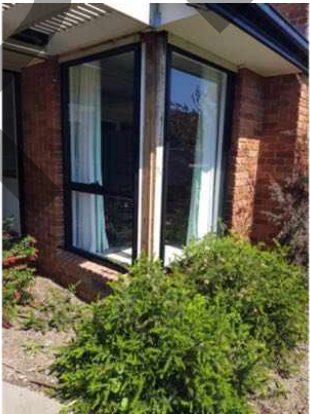
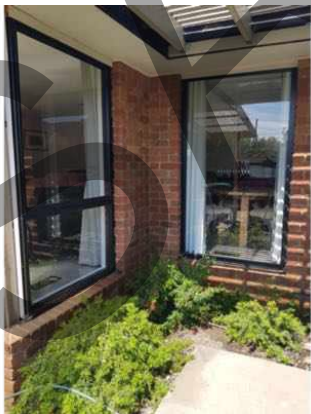
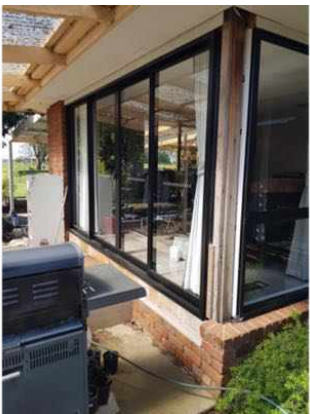
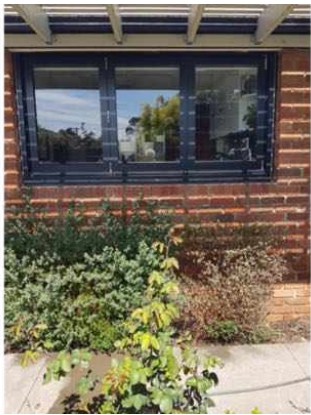
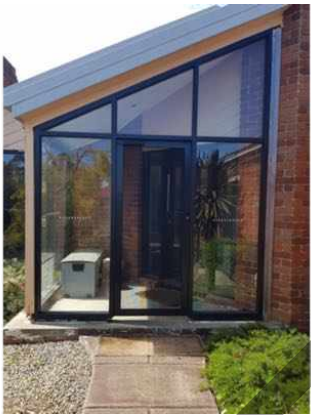
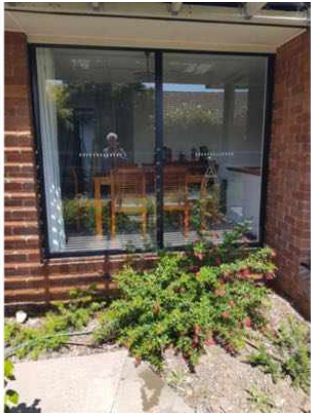
A number of windows were also replaced with aluminium windows. In the following areas dining, front lounge, side lounge, meals, kitchen, living sliding doors and front foyer. No defects are noted.

Finding: Window replacements

Information: No remedial works are required at the current time. Works have been completed to an acceptable level and do not pose any defects at the time of inspection.
