Insurance - Building Consulting Inspection

HEADLINE

Extensive cracking to interior walls, suspected to have resulted due to water damage.

Causation Report

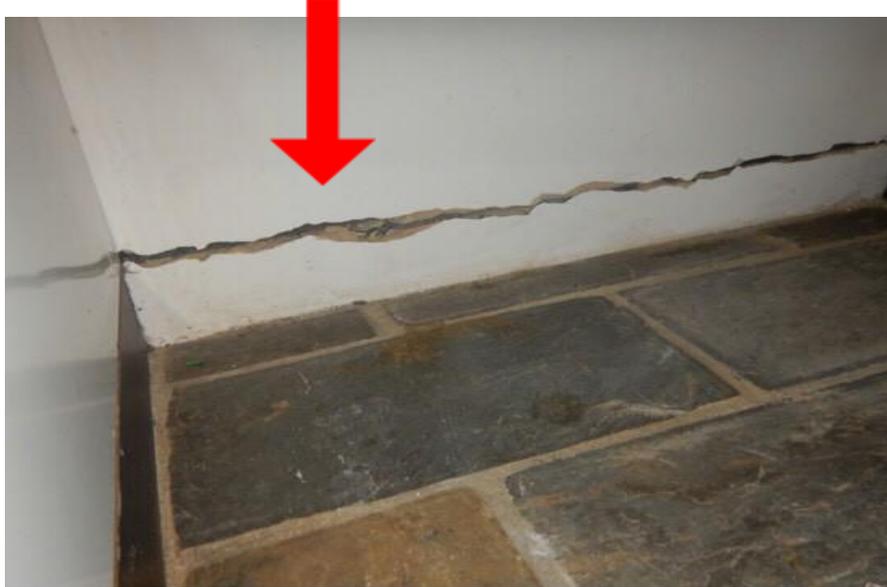
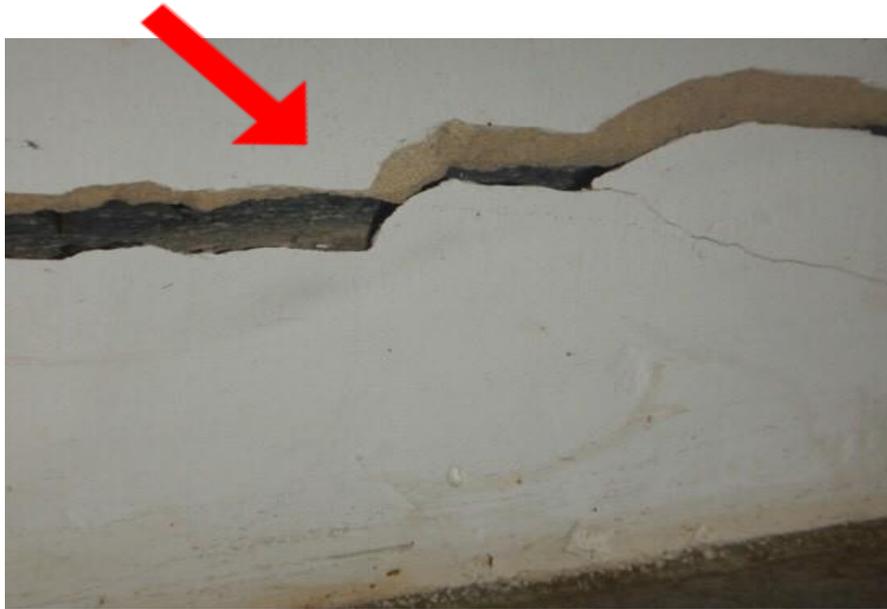
On the basis of my inspection on 14th December 2018, it is of my opinion that a water leak from the hot/cold water pipes, the waste pipes, or the hydronic heating pipes, has caused the failure in the footings/ slab, which has caused the cracking in the internal brick walls.

On inspection of the exterior of the building, minor fine brickwork cracking was identified. On inspection of the internal brick walls, the cracking was severe at the intersection of the passage, kitchen and laundry walls. The cracking in the fridge recess was between 10- 15mm in the first course of brickwork. The cracking along the remainder of passage walls was more evident at the door frames.

These photographs are of the fridge recess area, where cracking was most extensive.

A structural engineer should be engaged to investigate further and advise on a scope of works to rectify these issues.

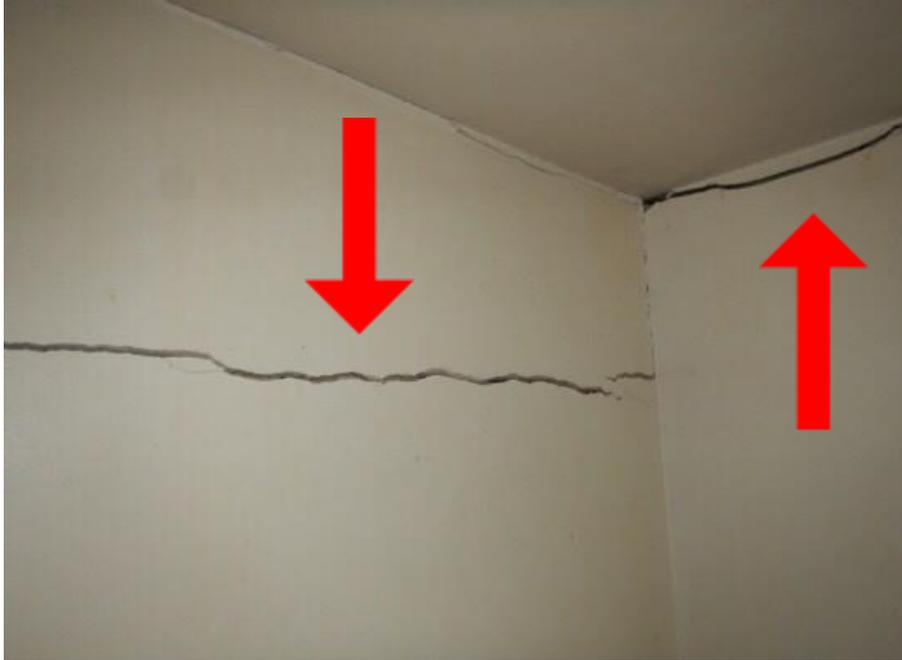
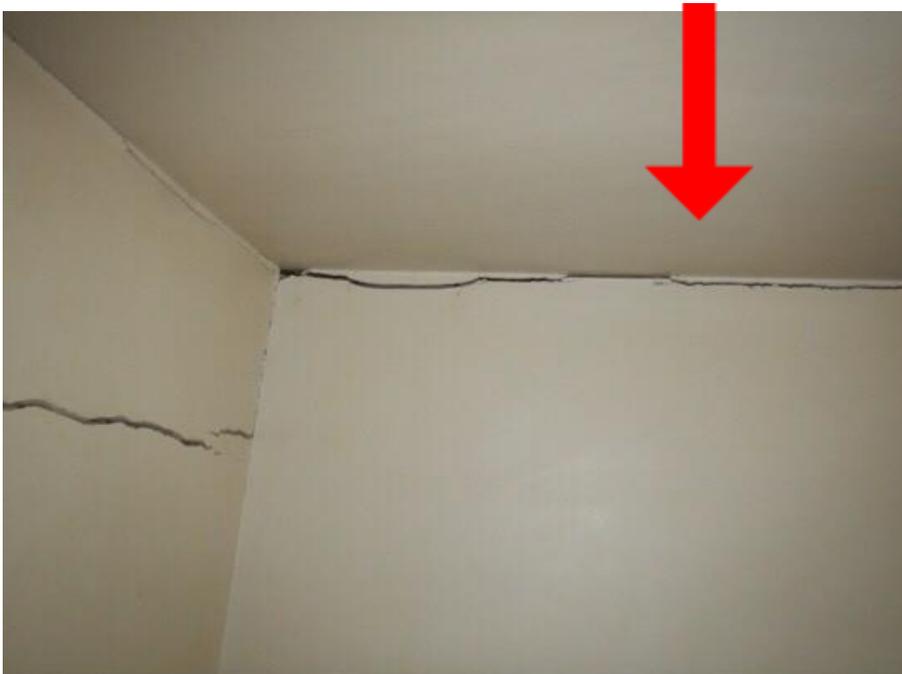
These photographs are of the fridge recess area, where cracking was most extensive.

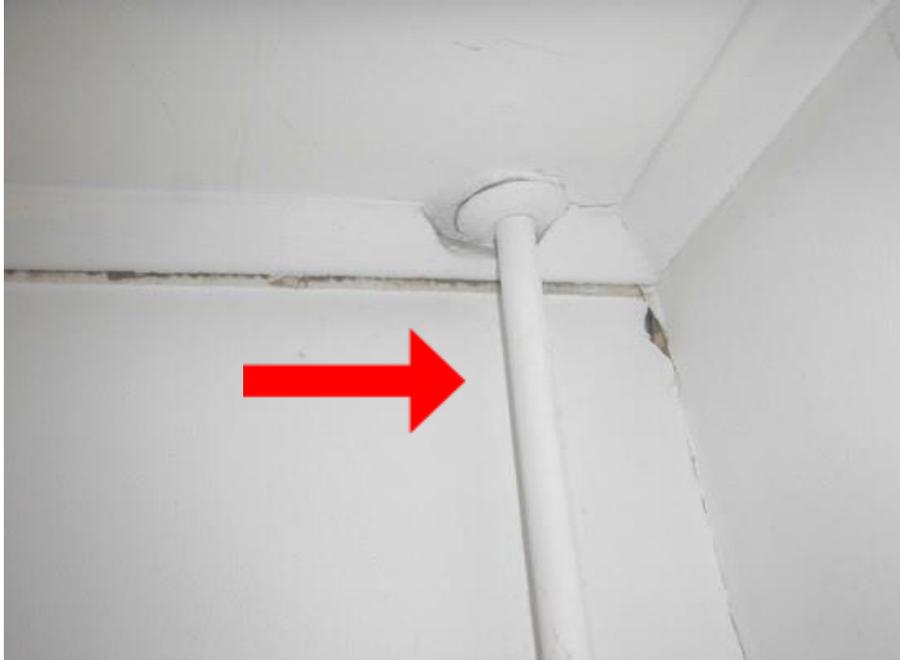
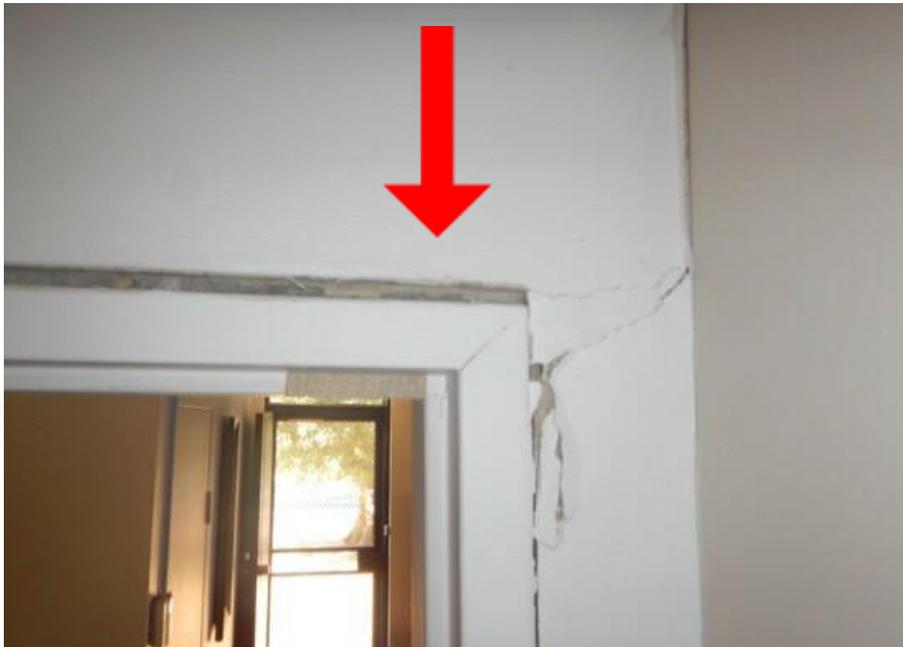
The cracking was extensive in the passage wall but reduced closer to the external walls. After inspection of the building, it is suspected that there is a failure in the slab/footings, which has ruptured a water/hydronic pipe or a waste pipe, causing leaking and the creation of movement in the surrounding ground.

These photographs are of the laundry area, showing the reduced cracking to external walls.

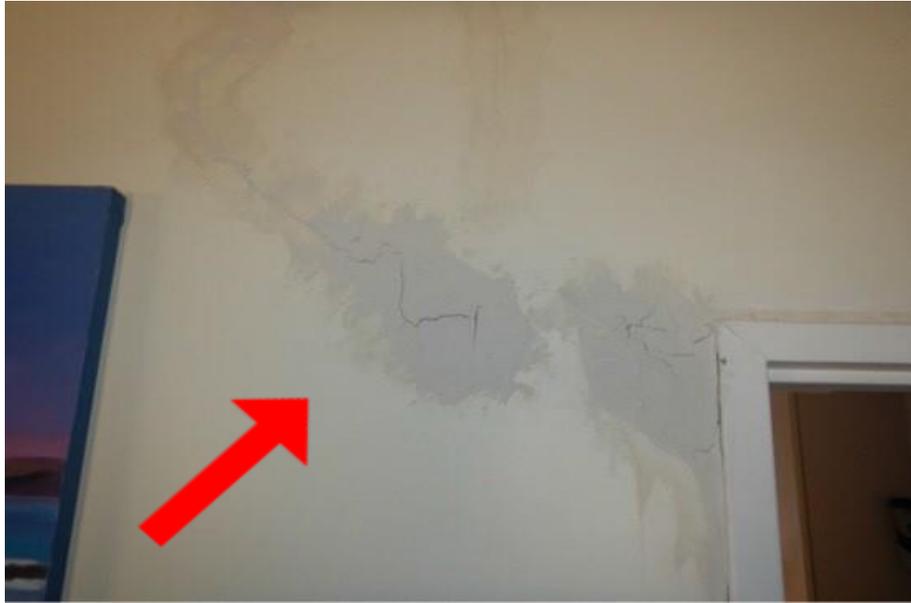
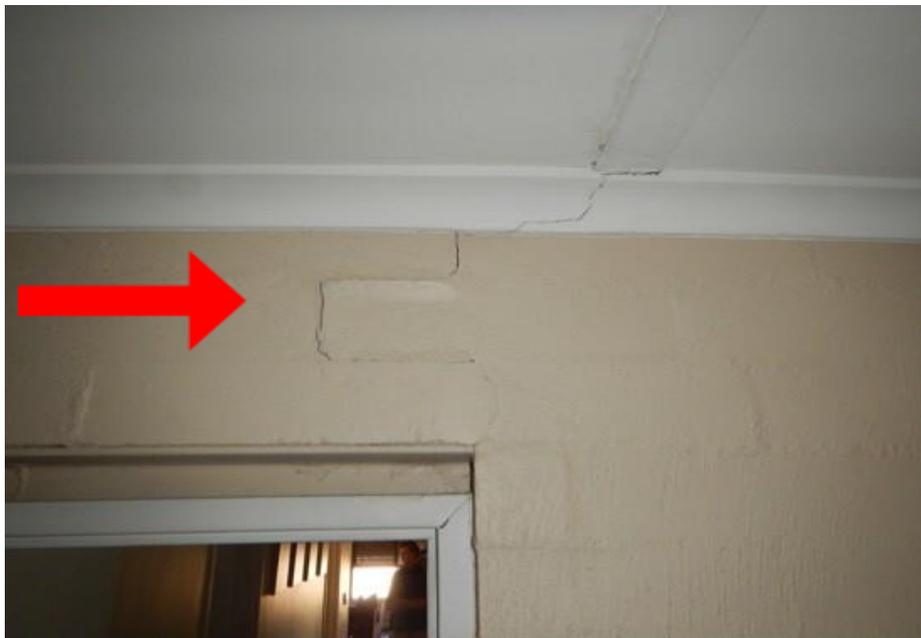
These photographs are of the rest of the house, showing noticeable cracking. Remedial works undertaken by homeowners are evident.

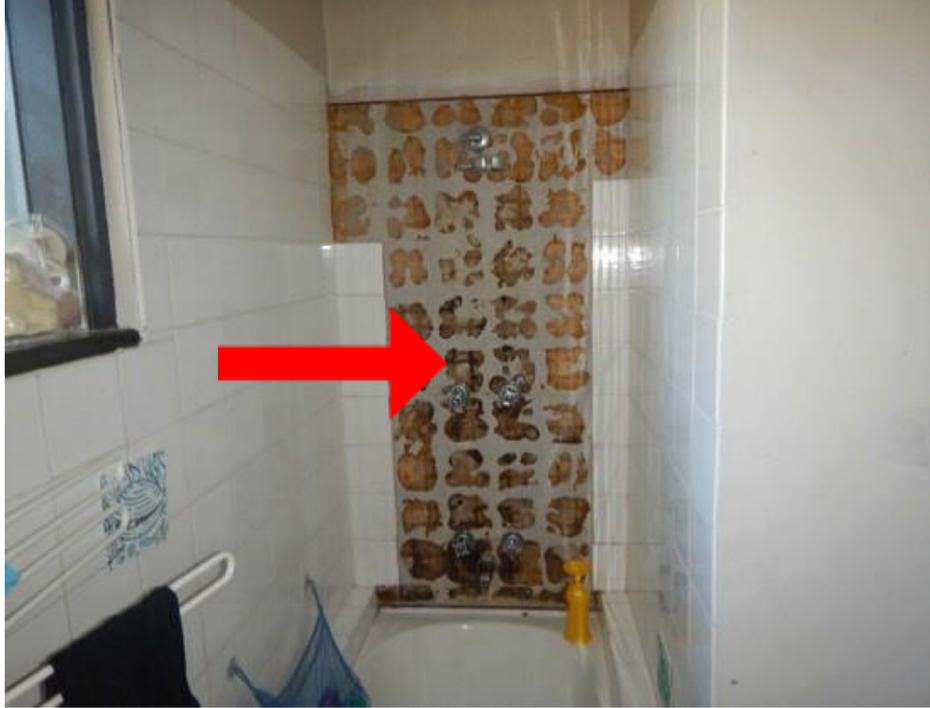
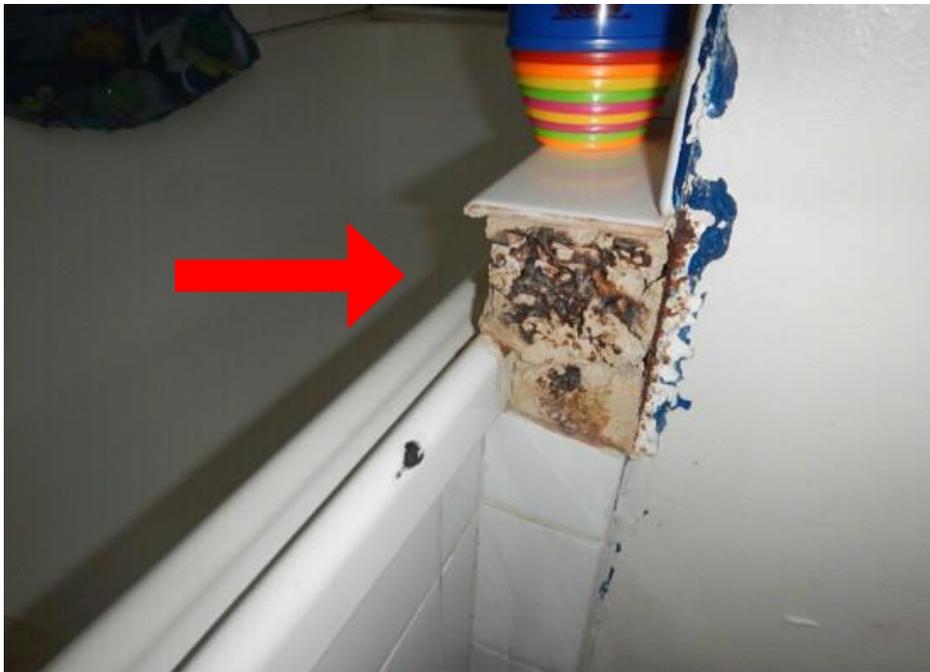
The bathroom has extensive tile damage and will need to be rectified to be able to be used safely.

These photographs showed damaged areas in the bathroom.

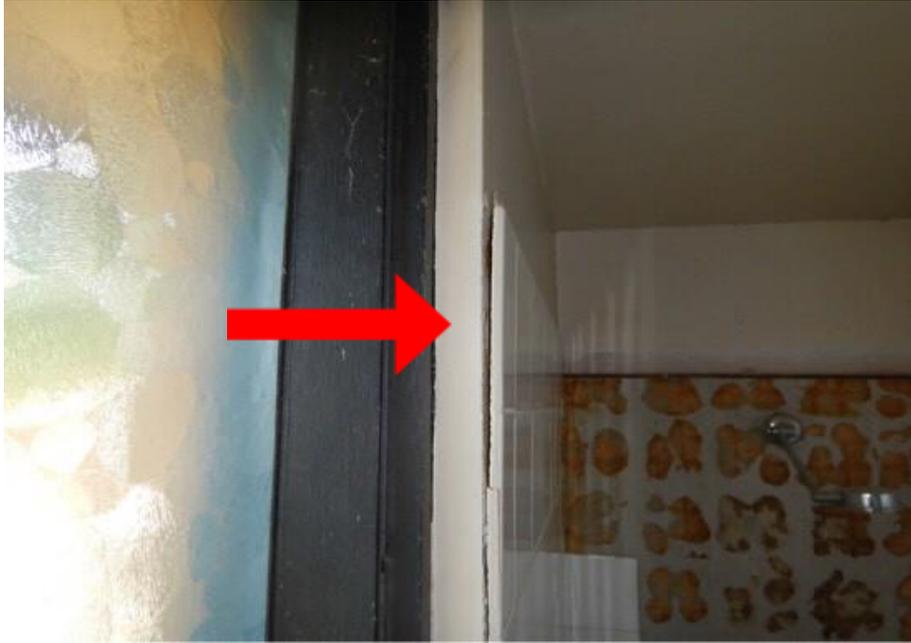
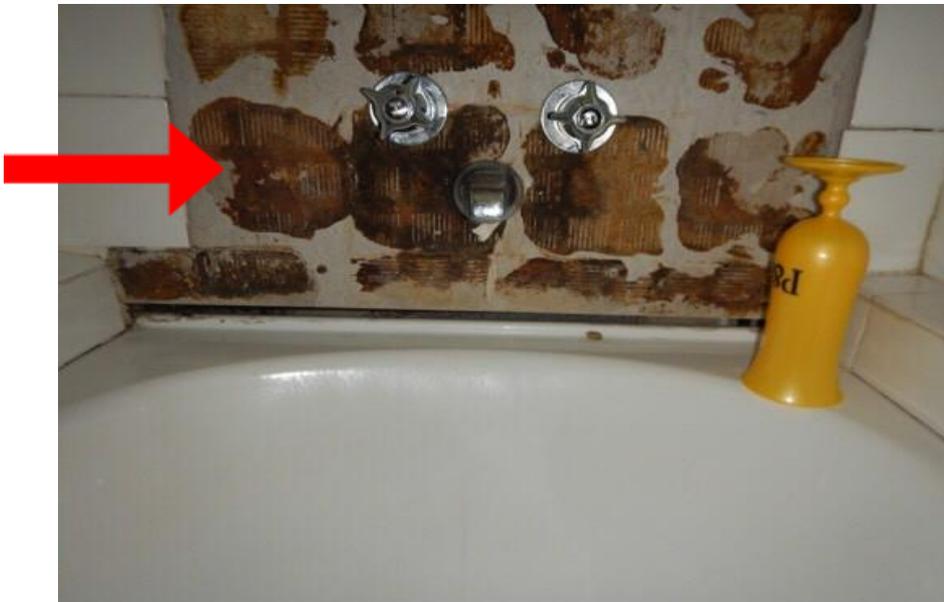
These photographs showed damaged areas in the bathroom.
