Building and Timber Pest Inspection Report

Company Name: Jim's Building Inspections (Marrickville)

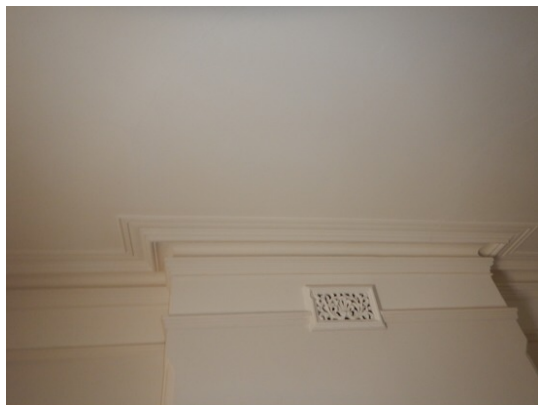
Finding 3.01

Building: Main Building

Location: Bedroom

Finding: Cracking - Damage Category 2 - Noticeable (up to 5mm)

Information: Noticeable cracks are a common occurrence as a result of many primary defects. Such causes may include age, general wear and tear, expected building movement, general expansion/contraction of building materials in different weather conditions, and/or minor failings in the installation or application of building materials.

Noticeable cracks may result in minor sticking or jamming of associated doors and windows, which require easement. However, noticeable cracks are easily filled and repaired. A plasterer can be consulted to install an expansion joint at this point to allow for this movement during different weather conditions.

Monitoring of all cracking should be conducted frequently. Always contact a building inspector should cracks widen, lengthen, or become more numerous. Additionally, your building inspector should also be contacted if associated building elements such as doors and windows become more difficult to operate over time.

Relevant tradespeople, such as carpenters, painters and plasterers, should be appointed to perform remedial works, as deemed necessary.

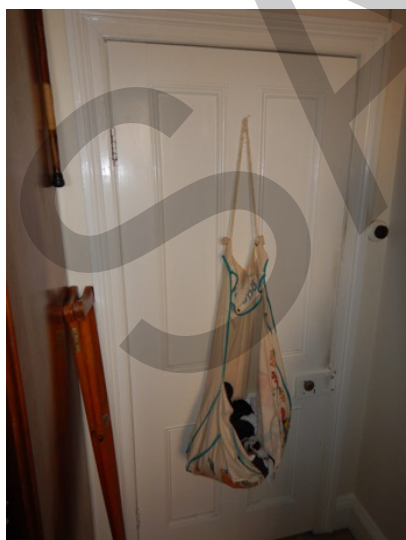
Finding 3.02

Building: Main Building

Location: Bedroom 2

Finding: Door - Binding/jamming

Information: Binding and/or jamming of this door is evident during standard operation. This defect inhibits the functionality of the affected door as well as creating potential for secondary defects to associated building elements, such as damage to the floor covering.

For minor causes, a qualified carpenter or general handyperson should be appointed to perform minor rectification works at client discretion.

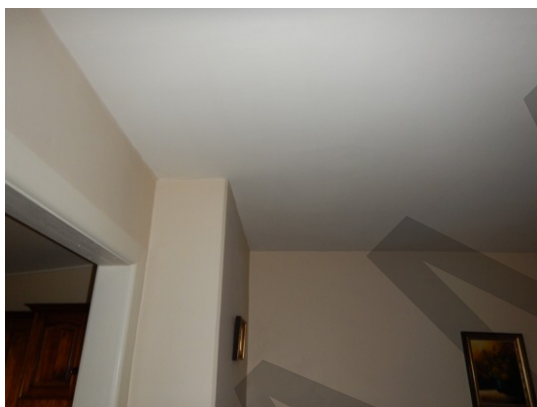
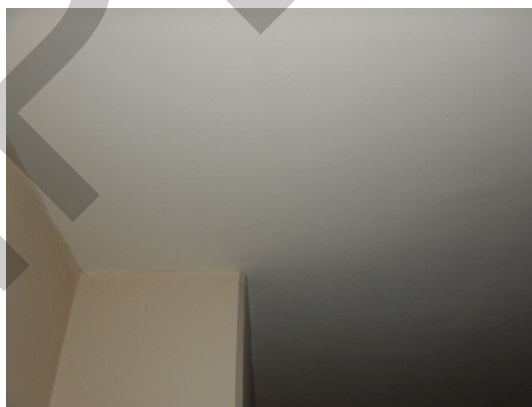
Finding 3.03

Building:	Main Building
Location:	Lounge Room
Finding:	Cracking - Damage Category 1 - Fine (up to 1mm)
Information:	Although fine cracks are quite noticeable, they are often only considered to be an appearance defect, and usually do not indicate any structural damage. Generally, the cause of a fine crack is indicative of a separation between building materials and finishes (e.g. paint, plaster, etc.) along joins.

Cracking of this nature can generally be repaired with minor sanding, filling and/or repainting. Such works should be performed by a qualified carpenter or a general handyman.

Monitoring of all cracking should be conducted frequently. Always contact a building inspector should cracks widen, lengthen, or become more numerous.

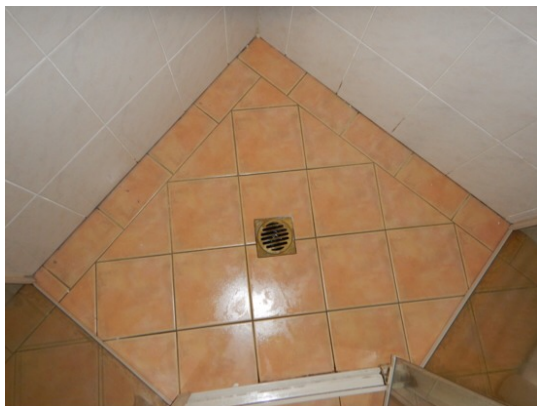
Finding 3.04

Building:	Main Building
Location:	Bathroom
Finding:	Tiles - Cracked or damaged
Information:	Cracking was evident to the tiling in this area at the time of inspection. While the cracking appears to be minor, this area is frequently exposed to water, allowing potential for water penetration into adjoining sections of walls or flooring.

If left unmanaged, water penetration to these areas may lead to subsequent water damage, which is likely necessitate repair work to affected building elements.

A tiling contractor should be appointed to ensure that no further water damage occurs. The

re-application of silicone and grouting throughout remaining tile work is also advised, to further protect the area against water penetration.

Where water penetration has led to water damage, appointment of a relevant tradesperson may be required to repair damaged building elements.

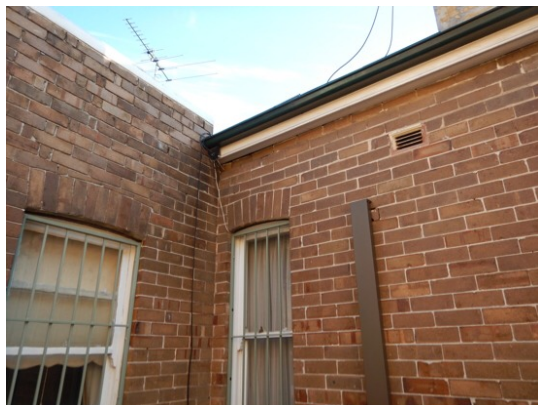
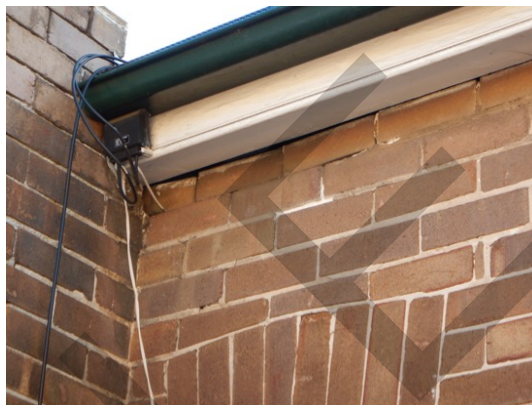
Finding 3.05

Building:	Main Building
Location:	Exterior walls - left side
Finding:	Brickwork - Deteriorated mortar
Information:	<p>Mortar, or 'bedding', is the material which fills joins and intersections between bricks in masonry walls and structures. Sections of mortar in this brickwork were identified as having deteriorated, which is generally expected for a property of this age and condition.</p> <p>Mortar may deteriorate as a result of age of building materials, minor movement of bricks, or frequent exposure to weathering. Mortar should be replaced to ensure that bricks remain in their intended location and to prevent gaps, which would allow water or moisture ingress and secondary damage as a result.</p> <p>Mortar deterioration can be addressed by a bricklayer where areas of deterioration are localised and easily accessible. Alternatively, appointment of a registered builder is advised, to repoint large areas of decaying mortar. Where secondary structural defects have become evident, consultation with a structural engineer may be required.</p>

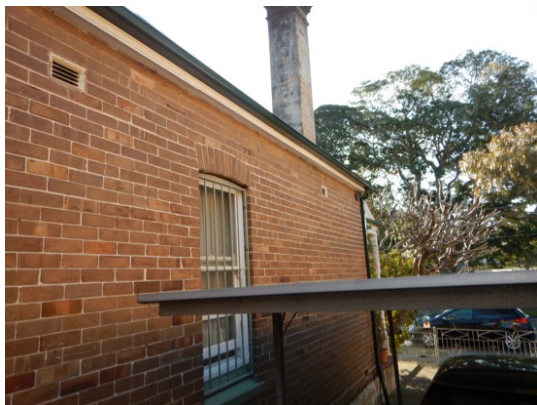
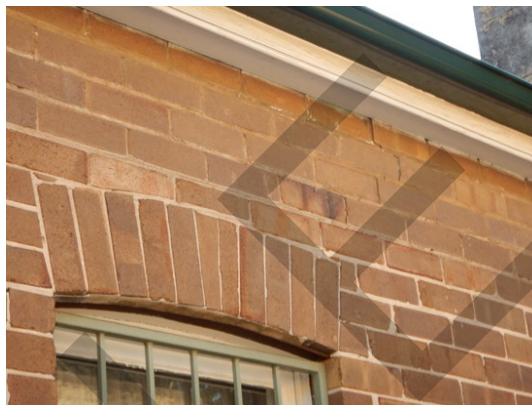
Finding 3.06

Building: Main Building

Location: Exterior walls - left side

Finding: Brickwork cracking - Noticeable

Information: Noticeable cracks are a common occurrence in external brickwork and are a likely result of age expected building movement, general expansion, and/or contraction of building materials in different weather conditions.

Noticeable cracks in brickwork may develop if left unattended, with potential for necessitating major remedial works or replacement of the brickwork.

It is highly advised that a qualified bricklayer be appointed to provide necessary works to cracked brickwork to prevent any further damage. Such works should be conducted as soon as possible.

Always monitor these cracks and contact a building inspector should cracks widen, lengthen, or become more numerous.

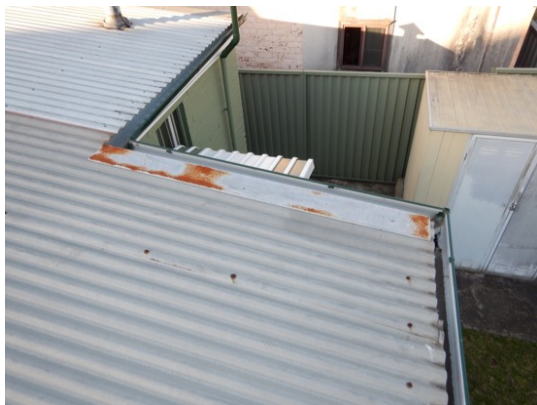
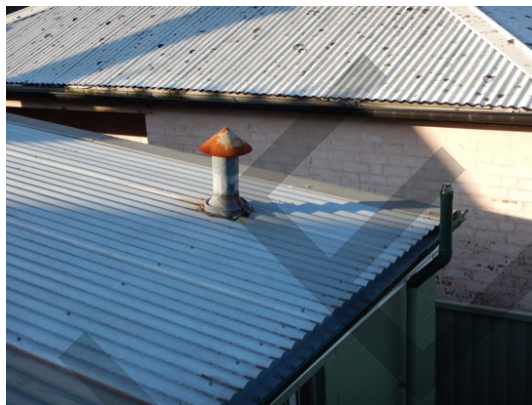
Finding 3.07

Building: Main Building

Location: Roof Exterior

Finding: Building element - Rusted or corroded

Information: This building element shows evidence of rusting and corrosion, which is likely to have developed as a result of excessive exposure to moisture.

As surface rust provides no protection to the underlying iron, the deteriorating condition is likely to worsen if not addressed in the short-term future.

Where possible, the use of galvanised (treated) metals or aluminium coated metals aid in rust prevention, as does regular general maintenance. Rust formation can be controlled with coatings, such as paint, that isolate the iron from the environment.

Rusting and corrosion should be managed by ideally removing or limiting the affected surface from exposure to moisture. A registered builder may be appointed to replace any building elements that have been severely affected by rust or water damage.

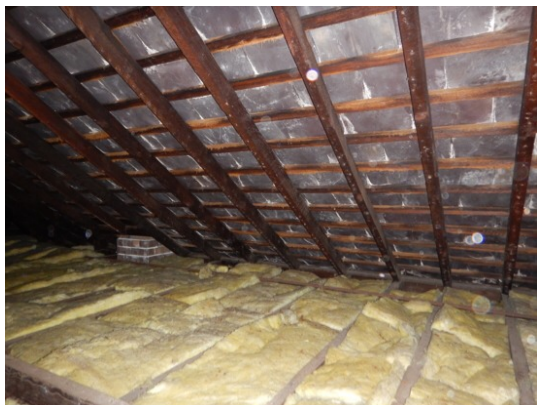
Finding 5.01

Building: Main Building

Location: Roof Void

Finding: Chemical delignification identified

Information: Chemical delignification also known as wood defibration refers to the chemical breakdown of timber building elements. This breakdown of the Lignin deteriorates the wood impacting on the structural integrity and tensile strength of the affected building element.

Chemical delignification is most common near marine environments due to the high levels of salt in the air however this deterioration may also occur in other areas where timber elements are frequently exposed to damaging gases chemicals etc.

Where timber building elements have deteriorated repair and / or replacement is required immediately to ensure the safety of the associated structures. The likely cause of the defibration should also be investigated and dealt with accordingly.

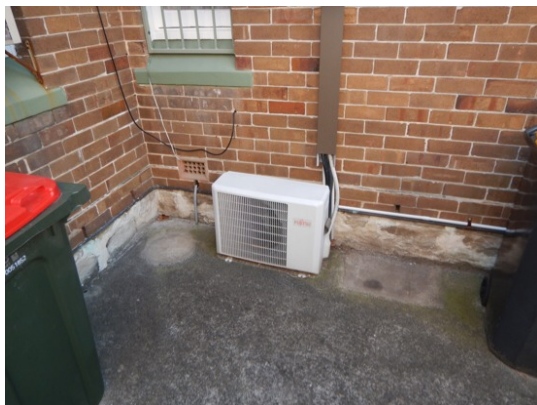
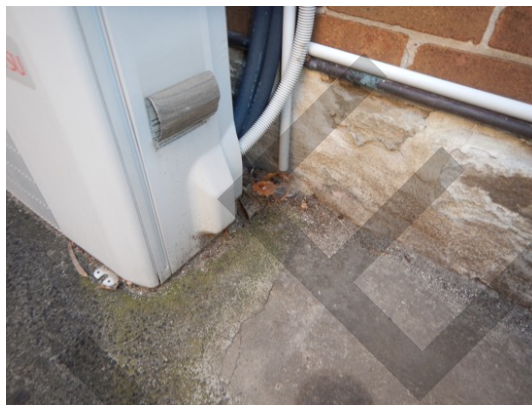
Finding 6.01

Building: Main Building
Location: Exterior walls - left side
Finding: Air conditioner - Disconnected overflow
Information: The Air Conditioner (A/C) overflow was found to be disconnected from storm water draining and is creating excessive moisture in the surrounding area.

Such leaking creates an environment which is conducive to an array of defects, including water damage to associated building elements and the attraction of termite or timber pest infestation.

It is highly recommended that a licensed plumber be appointed to connect the A/C overflow in order to prevent such an environment from being created. These minor works should be carried out as soon as possible.
