Asbestos Inspection and Condition Report (Sampling)

Original Inspection Date	Thu, 20 Nov 2014
Modified Date	Sat, 22 Nov 2014
Modified Date	Mon, 24 Nov 2014

Company Name: Jim's Building Inspections FSO (Sydney North)

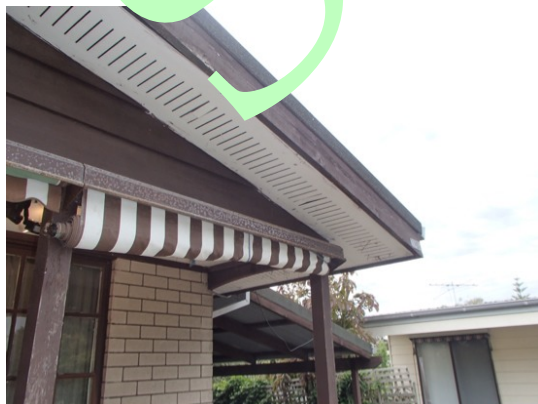
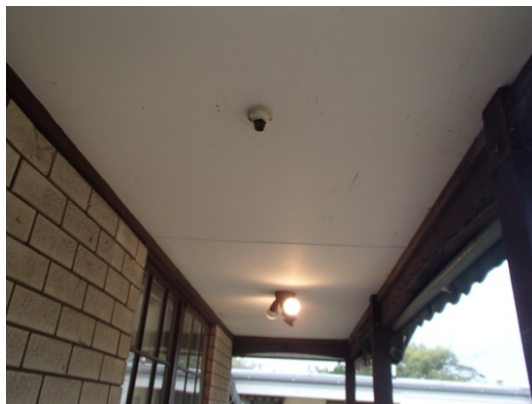
Building: Main Building
 Location: Eaves
 Finding: ACM Suspected Eave Sheets
 Information: The eave sheets throughout the exterior of the property appear to be an asbestos containing material (ACM). The observable areas of the sheeting appears to have no obvious signs of damage or deterioration, indicating that the asbestos is currently encapsulated and contained.

A sample for lab analysis to confirm the presence of asbestos was taken from this location. The client is advised to assume the affected area and construction material contains Asbestos until the lab analysis results are available. The area should be avoided and no works should be undertaken on the area until this time.

Removal by a Licensed Asbestos Removal firm is highly advised. Where the client elects to retain the suspected ACM, the condition of all eave sheeting should be monitored annually (more frequent inspections are required should damage or evidence of deterioration occur). Inspection should also cover factors that may lead to the deterioration of the eave sheets, such as minor roof leaks or damage to associated building elements.

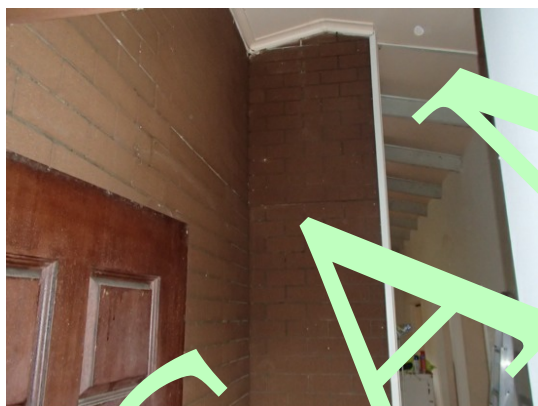
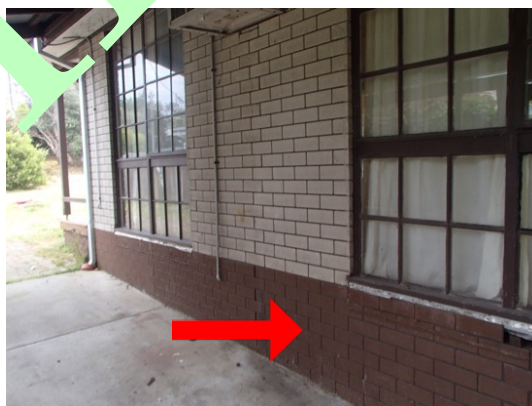
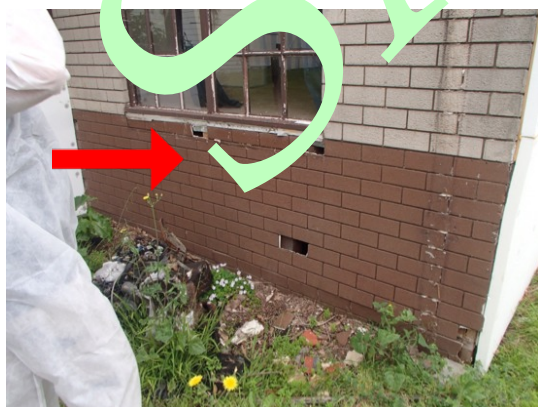
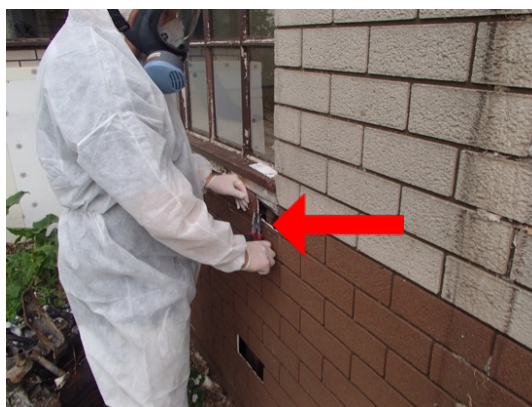
Asbestos, Asbestos Containing Materials and Asbestos Dust 2.02

Information: Several forms of artificial or fake brick 'look' cladding materials contain Asbestos. At the time of the inspection the observable areas of the cladding appear to be free of damage and deterioration.

However any attachment point eg: subsequent external fixing or the use of tools to apply or install an item onto the cladding and even minor impact damage or deterioration has the potential to release airborne asbestos fibres. Damaged and deteriorated ACMs have a higher probability of releasing airborne asbestos fibres creating a significant health safety risk.

Removal by a Licensed Asbestos Removal firm would be advised. Where the client elects to retain the ACM the client should regularly monitor (at least annually but more frequently should damage or evidence of deterioration or any condition of the cladding material to identify any further damage or deterioration. This is particularly important where the cladding is present in highly traffic-able areas such as doorway or adjacent walkways.

No works should be carried out to the ACM or associated building elements without further specialist advice.

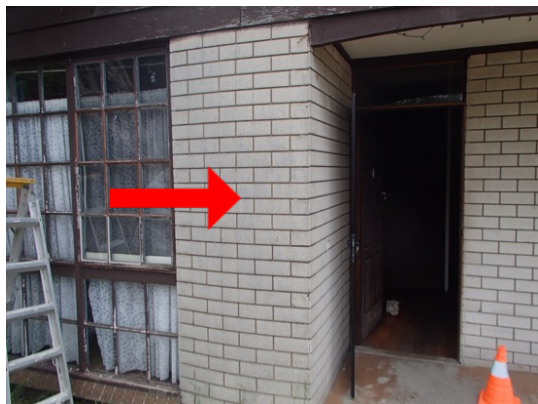
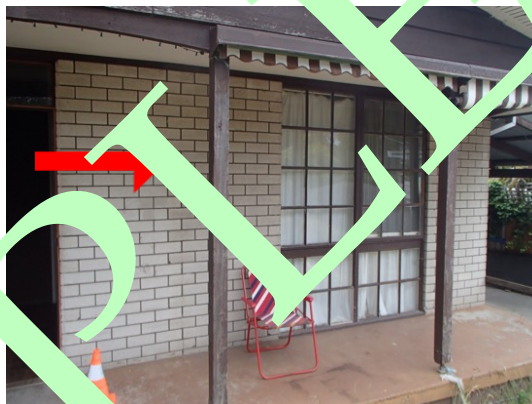
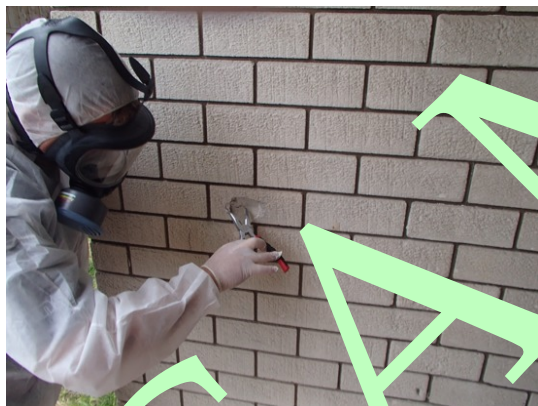
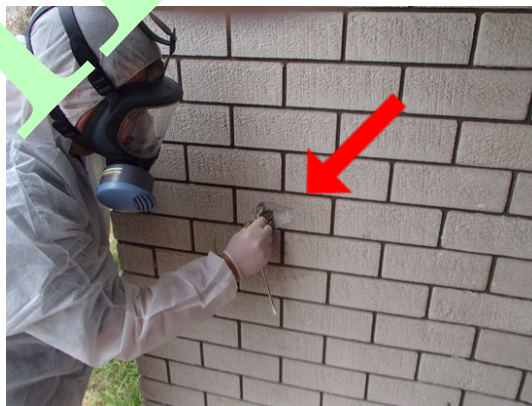
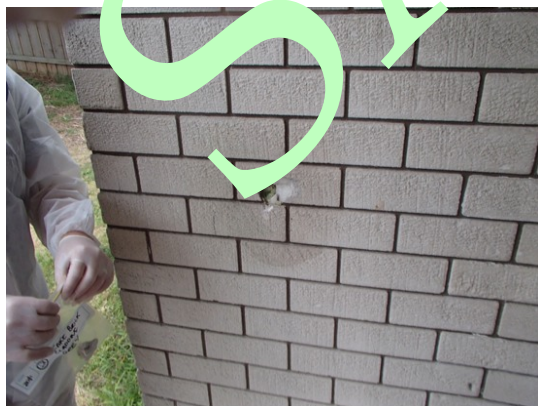
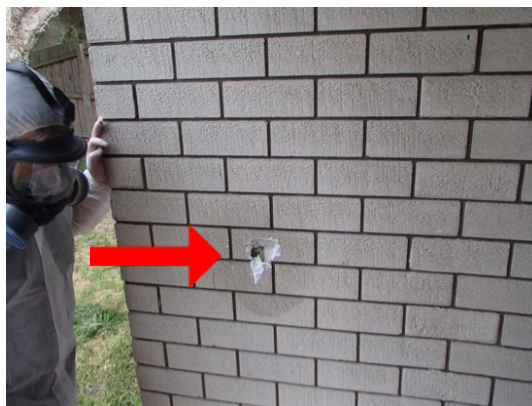
Asbestos, Asbestos Containing Materials and Asbestos Dust 2.03

Building:	Main Building
Location:	All External Areas
Finding:	ACM Suspected Artificial 'Fake Brick' Cladding - Grey
Information:	<p>Several forms of artificial or 'fake brick' cladding materials contain Asbestos. At the time of the inspection the observable areas of the cladding appear to be free of damage and deterioration.</p> <p>However, any subsequent point e.g. subsequent external fixing or the use of tools to apply or install anything onto the cladding and even minor impact damage or deterioration has the potential to release airborne asbestos fibres. Damaged and deteriorated ACMs have a higher probability of releasing airborne asbestos fibres creating a significant health safety risk.</p> <p>A sample for lab analysis to confirm the presence of asbestos was taken from this location. The client is advised to assume the affected area and construction material contains Asbestos until the lab analysis results are available.</p> <p>Given the entire property is clad in the material avoidance and isolation of the material is generally impracticable. However any unnecessary contact and certainly any works such as the use of tools to affix anything to the building should be avoided until lab analysis results are available.</p> <p>Removal by a Licensed Asbestos Removal firm would be advised. Where the client elects to retain the ACM the client should regularly monitor (at least annually but more frequently should damage or evidence of deterioration occur) the condition of the cladding material to identify any further damage or deterioration. This is particularly important where the cladding is present in highly traffic-able areas such as doorways or adjacent to fixings.</p>

No works should be carried out to the ACM or associated building elements without further specialist advice.

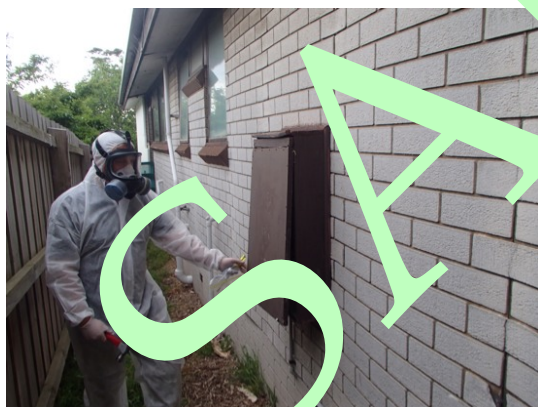
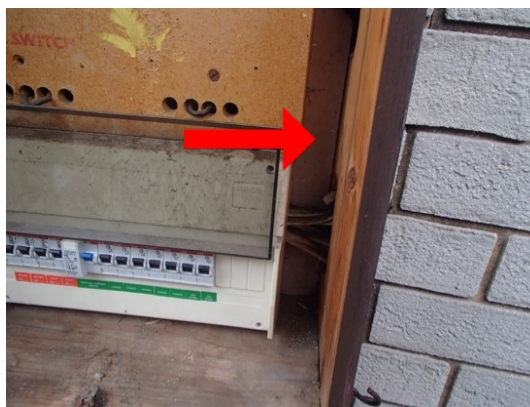
Asbestos, Asbestos Containing Materials and Asbestos Dust 2.04

Information: Historically asbestos containing materials (ACM) were used in electrical switchboards to insulate the area and were even used within old electrical fuses. It is suspected that the electrical switchboard backing in this property has been constructed using Asbestos. The electrical switchboards appear to be free of damage and are the suspected ACM. It appears to be in a bonded condition which represents a lesser health and safety risk than if they were in a poor or deteriorating condition. A sample for lab analysis to confirm the presence of asbestos was taken from this location. The client is advised to assume the affected area and construction material contains Asbestos until the lab analysis results are available. The area should be avoided and no works should be undertaken on the area until lab analysis results are available. Removal by a Licensed Asbestos Removal firm in conjunction with a licensed electrician would be advised. Where the client elects to retain the ACM the client should regularly monitor (at least annually but more frequently should damage or evidence of deterioration occur) the condition of the switchboards to identify any further damage or deterioration.

No works should be carried out to the switchboards or fuses or associated building elements without further specialist advice.

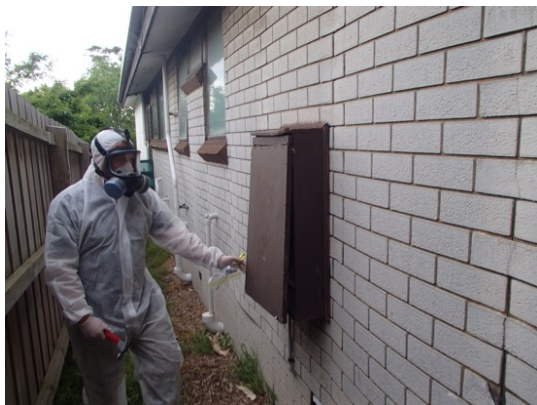
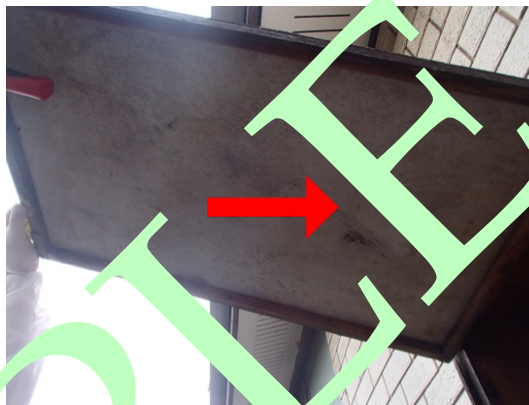
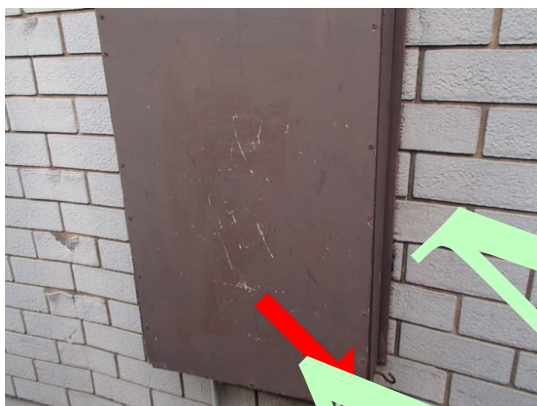
Asbestos, Asbestos Containing Materials and Asbestos Dust 2.05

Building:	Main Building
Location:	Exterior walls - left side
Finding:	ACM Suspected Damage leading to switchboard
Information:	<p>The sheeting to the door to the electrical switchboard is suspected to have been constructed with the use of asbestos-containing materials (ACM). The observable areas of sheeting appears to have no obvious signs of damage or deterioration indicating that the asbestos is currently encapsulated and contained. Damaged and deteriorated ACMs have a higher probability of releasing airborne asbestos fibres creating a significant health safety risk.</p> <p>A sample for lab analysis to confirm the presence of asbestos was taken from this location. The client is advised to assume the affected area and construction material contains Asbestos until the lab analysis results are available. The area should be avoided and no work should be undertaken on the area until lab analysis results are available. Removal by a Licensed Asbestos Removal firm would be advised. Where the client elects to retain the ACM the client should regularly monitor (at least annually but more frequently should damage or evidence of deterioration occur) the condition of the sheeting to identify any further damage or deterioration. Additional remedial work is a potential short to medium term solution to reduce the risk presented by the ACM.</p>

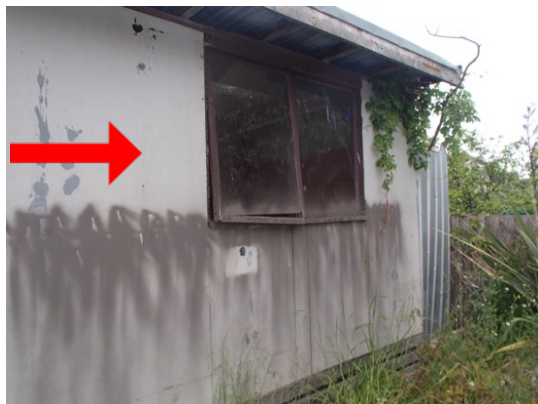
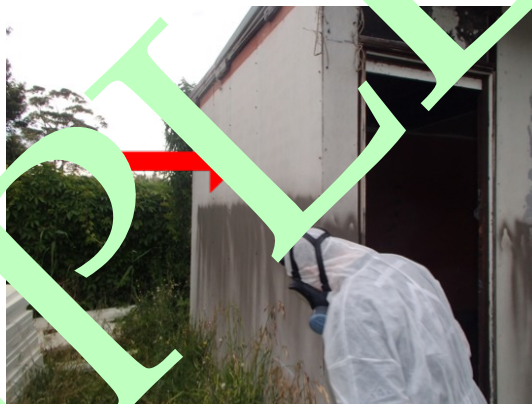
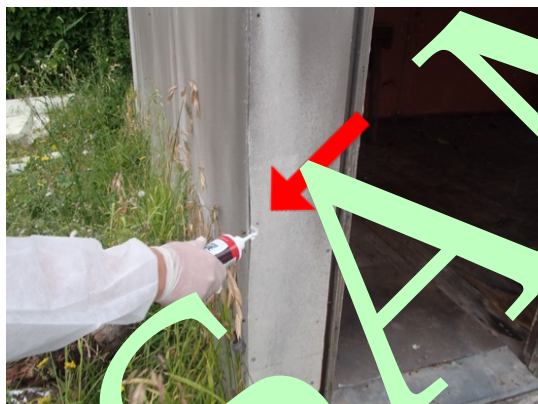
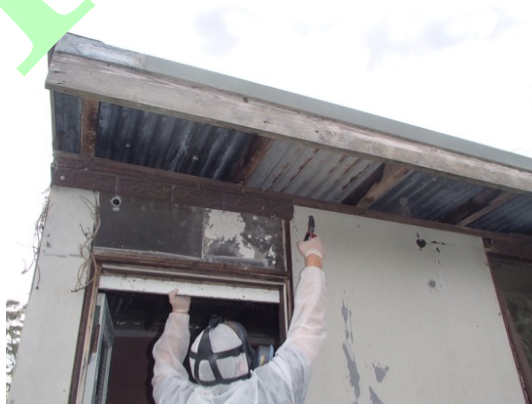
Asbestos, Asbestos Containing Materials and Asbestos Dust 2.06

Information: Walls throughout the exterior of the shed is suspected to have been constructed with the use of asbestos-containing materials (ACM). The observable areas of wall sheeting appears to have no obvious signs of damage or deterioration indicating that the asbestos is currently encapsulated and contained. Damaged and deteriorated ACMs have a higher probability of releasing airborne asbestos fibres creating a significant health safety risk.

A sample for lab analysis to confirm the presence of asbestos was taken from this location. The client is advised to assume the affected area and construction material contains Asbestos until the lab analysis results are available. The area should be avoided and no works should be undertaken on the area until lab analysis results are available. Removal by

a Licensed Asbestos Removal firm would be advised. Where the client elects to retain the ACM the client should regularly monitor (at least annually but more frequently should damage or evidence of deterioration occur) the condition of the wall sheets to identify any further damage or deterioration. Additional remedial work is a potential short to medium term solution to reduce the risk presented by the ACM. Where possible

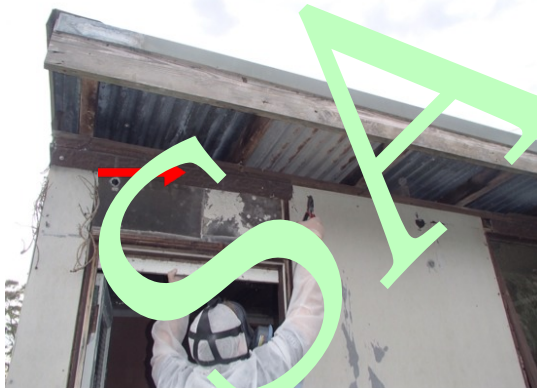
Asbestos, Asbestos Containing Materials and Asbestos Dust 2.07

Building:	Main Building
Location:	Shed
Finding:	ACM Suspected Artificial or Fake Brick Cladding
Information:	Several forms of artificial or fake brick 'look' cladding materials contain Asbestos. At the time of the inspection the observable areas of the cladding appear to be free of damage and deterioration.

However any attachment point eg: subsequent external fixing or the use of tools to apply or install an item onto the cladding and even minor impact damage or deterioration has the potential to release airborne asbestos fibres. Damaged and deteriorated ACMs have a higher probability of releasing airborne asbestos fibres creating a significant health/safety risk.

Removal by a Licensed Asbestos Removal firm would be advised. Where the client elects to retain the ACM the client should regularly monitor at least annually but more frequently should damage or evidence of deterioration occur, the condition of the cladding material to identify any further damage or deterioration. This is particularly important where the cladding is present in highly traffic-able areas such as doorways or adjacent to fixings.

No works should be carried out to the ACM or associated building elements without further specialist advice.

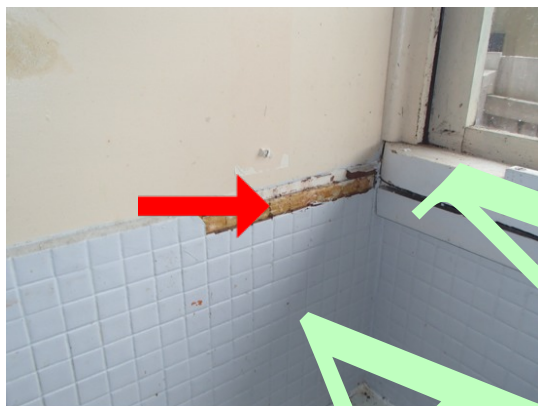
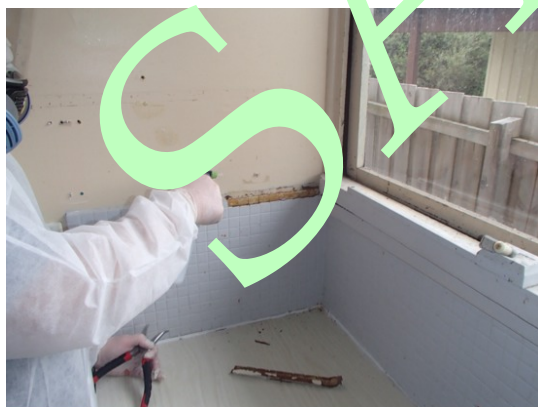
Asbestos, Asbestos Containing Materials and Asbestos Dust 2.08

Building:	Main Building
Location:	Kitchen and Laundry
Finding:	ACM Suspected behind Ceramic Tiles

The sheet construction material behind the ceramic tiles in this area is suspected to be an asbestos containing material (ACM). Often found in bathrooms and kitchen environments in this construction context in buildings pre 1985.

The observable areas of sheeting appear to be bonded undamaged and free of deterioration. Damaged and deteriorated ACM's have a higher probability of releasing airborne asbestos fibres creating a significant health and safety risk.

A sample for lab analysis to confirm the presence of asbestos was taken from this location. The client is advised to assume the affected area and construction material contains Asbestos until the lab analysis results are available.

The area should be avoided and no works should be undertaken on the area until lab analysis results are available. Should Asbestos be confirmed the client should arrange for removal by a Licensed Asbestos Removal firm.

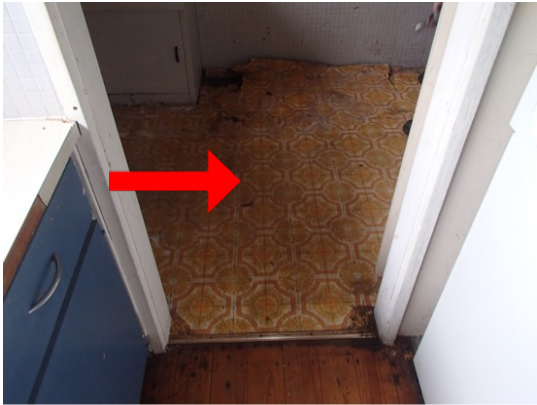
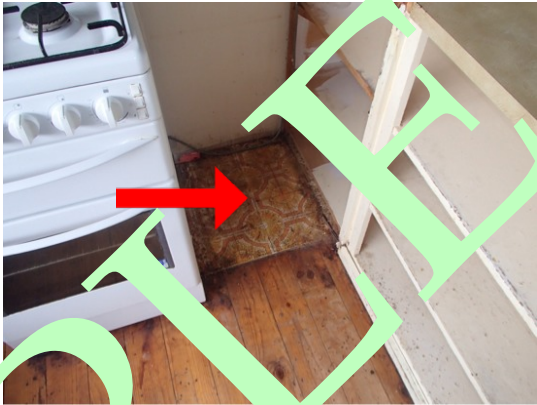
Asbestos, Asbestos Containing Materials and Asbestos Dust 2.09

Building: Main Building
 Location: Kitchen and Laundry and sunroom
 Finding: ACM Suspected vinyl floor covering
 Information: Vinyl floor covering may have several asbestos containing materials (ACM) including within the vinyl body of the sheeting or as a fibrous backing to the tiles or as an asbestos-based adhesive used to fix the tiles to the adjoining floor. At the time of the inspection the observed areas of vinyl flooring appear to be free of damage or deterioration. Damaged and deteriorated ACMs have a higher probability of releasing airborne asbestos fibres creating a significant health and safety risk.

A sample for lab analysis to confirm the presence of asbestos was taken from this location. The client is advised to assume the affected area and construction material contains Asbestos until the lab analysis results are available. The area should be avoided and no works should be undertaken on the area until lab analysis results are available. Removal by a Licensed Asbestos Removal firm would be advised. Where the client elects to retain the ACM the client should regularly monitor (at least annually but more frequently should damage or evidence of deterioration occur) the condition of the vinyl flooring to identify any further damage or deterioration. This is particularly important where the vinyl flooring is present in a trafficable or highly trafficable area.

No works should be carried out to the ACM or associated building elements without further specialist advice.

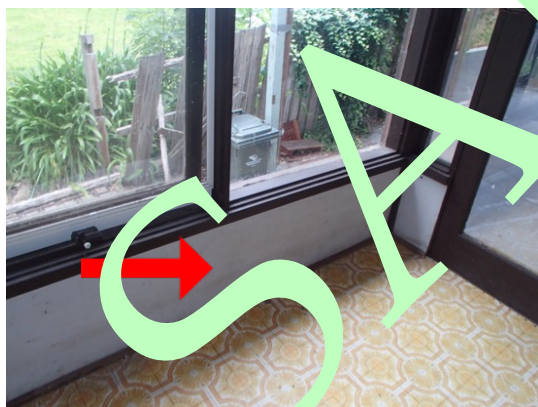
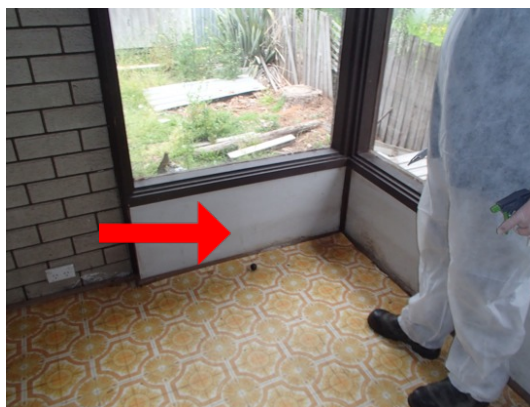
Asbestos, Asbestos Containing Materials and Asbestos Dust 2.1

Information: Walls to the sunroom are suspected to have been constructed with the use of asbestos-containing materials (ACM). The observable areas of wall sheeting appears to have no obvious signs of damage or deterioration indicating that the asbestos is currently encapsulated and contained. Damaged and deteriorated ACMs have a higher probability of releasing airborne asbestos fibres creating a significant health and safety risk.

A sample for lab analysis to confirm the presence of asbestos was taken from this location. The client is advised to assume the affected area and construction material contains Asbestos until the lab analysis results are available. The area should be avoided and no works should be undertaken on the area until lab analysis results are available. Removal by a Licensed Asbestos Removal firm would be advised. Where the client elects to retain the ACM the client should regularly monitor (at least annually but more frequently should damage or evidence of deterioration occur) the condition of the wall sheets to identify any further damage or deterioration. Additional remedial work is a potential short to medium term solution to reduce the risk presented by the ACM.

This type of cladding was also noticed above the entry door to the sunroom externally

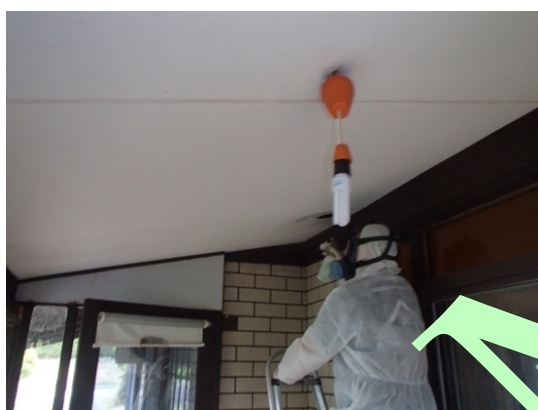
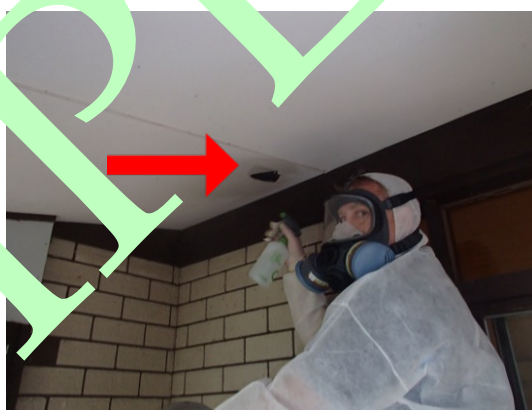
Asbestos, Asbestos Containing Materials and Asbestos Dust 2.11

Information: Ceilings to the sunroom appear to have been constructed with the use of asbestos-containing materials (ACM). The observable areas of the ceiling sheets were free of damage and deterioration which represents a lesser health and safety risk than if they were in a poor damaged or deteriorating condition.

ACM the client should regularly monitor (at least annually but more frequently should damage or evidence of deterioration occur) the condition of the ceiling sheets to identify any further damage or deterioration. Inspection should also cover factors that may lead to the deterioration of the ceilings such as minor roof leaks or structural movement. Additional remedial work is a potential short to medium term solution to reduce the risk presented by the ACM. Where possible the encapsulation of the asbestos materials using an appropriate sealant again by a specialist contractor can be considered.

No works should be carried out to the ACM or associated building elements without further specialist advice.

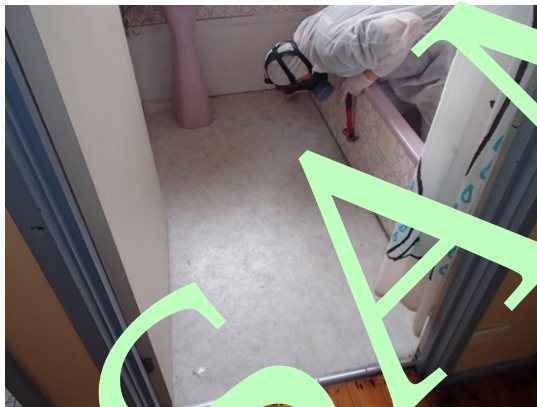
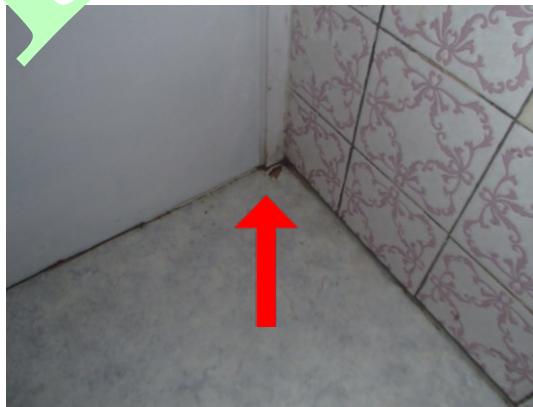
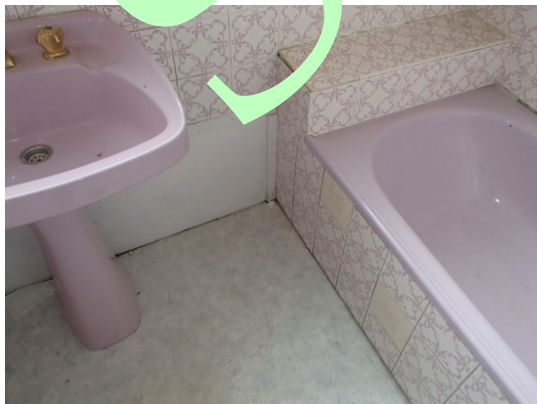
Asbestos, Asbestos Containing Materials and Asbestos Dust 2.12

Building:	Main Building
Location:	Bathroom
Finding:	ACM Suspected Vinyl Floor Covering

Vinyl floor covering may have several asbestos containing materials (ACM) including within the vinyl body of the sheeting or as a fibrous backing to the tiles or as an asbestos-based adhesive used to fix the tiles to the adjoining floor. At the time of the inspection, the observable areas of vinyl flooring appear to be free of damage or deterioration. Damaged and deteriorated ACMs have a higher probability of releasing airborne asbestos fibres, creating a significant health safety risk.

A sample for lab analysis to confirm the presence of asbestos was taken from this location. The client is advised to assume the affected area and construction material contains Asbestos until the lab analysis results are available. The area should be avoided and no works should be undertaken on the area until lab analysis results are available. Removal by a Licensed Asbestos Removal firm would be advised. Where the client elects to retain the ACM the client should regularly monitor (at least annually but more frequently should damage or evidence of deterioration occur) the condition of the vinyl flooring to identify any further damage or deterioration. This is particularly important where the vinyl flooring is present in a trafficable or highly trafficable area.

No works should be carried out to the ACM or associated building elements without further specialist advice.

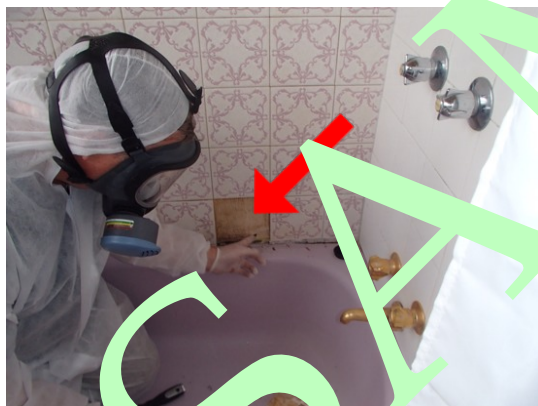
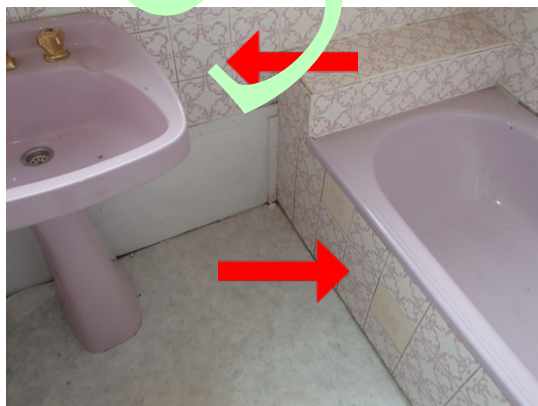
Asbestos, Asbestos Containing Materials and Asbestos Dust 2.13

Information: The sheet construction material behind the ceramic tiles in this area is suspected to be an asbestos containing material (ACM). Often found in bathrooms and kitchen environments in this construction context in buildings pre 1985. The observable areas of sheeting appear to be bonded and damaged and free of deterioration. Damaged and deteriorated ACM's have a higher probability of releasing airborne asbestos fibres creating a significant health and safety risk.

A sample for lab analysis to confirm the presence of asbestos was taken from this location. The client is advised to assume the affected area and construction material contains Asbestos until the lab analysis results are available.

The area should be avoided and no works should be undertaken on the area until lab analysis results are available. Should asbestos be confirmed the client should arrange for removal by a Licensed Asbestos Removal firm.

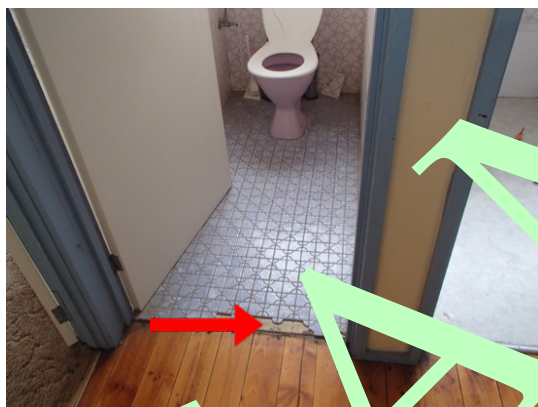
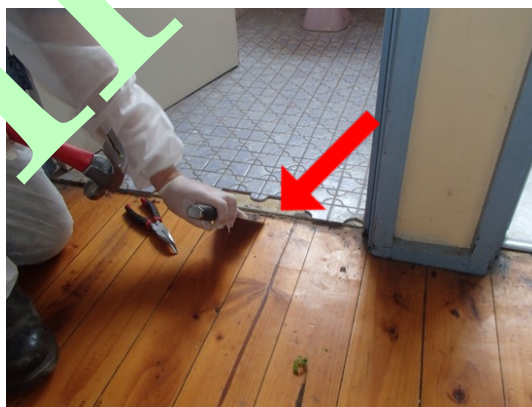
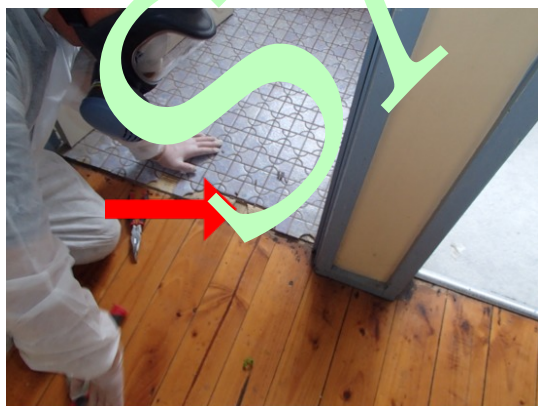
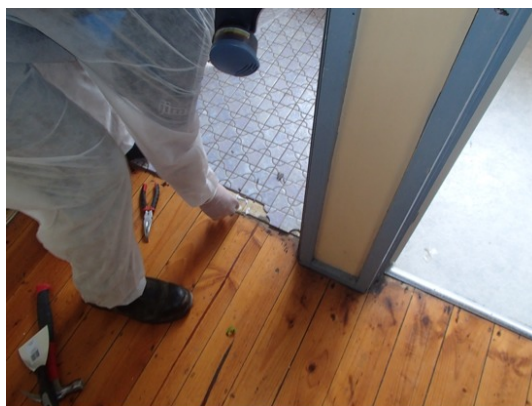
Asbestos, Asbestos Containing Materials and Asbestos Dust 2.14

Finding: ACM Suspected Tile Floor Underlay

Information: The Tile floor covering underlay is suspected to be an asbestos-containing material (ACM). The observable areas of the floor underlay appear to be free of damage and deterioration which represents a lesser health and safety risk than if they were in a poor or deteriorating condition. A sample for lab analysis to confirm the presence of asbestos was taken from this location. The client is advised to assume the affected area and construction material contains Asbestos until the lab analysis results are available. The area should be avoided and no works should be undertaken on the area until lab analysis results are available. Removal by a Licensed Asbestos Removal firm would be advised. Where the client elects to retain the ACM the client should regularly monitor (at least annually but more frequently should damage or evidence of deterioration occur).

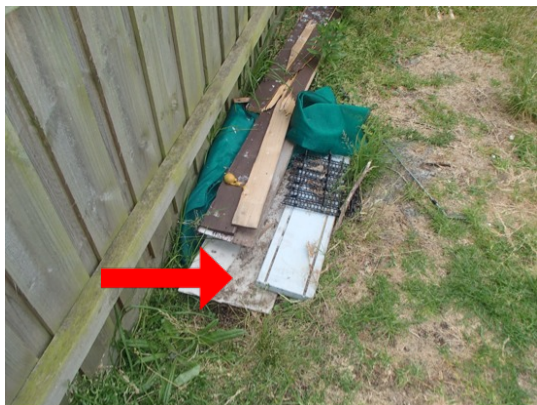
Information: Suspected Asbestos Containing Material was identified in debris or rubbish found on the site. The materials are suspected to contain Asbestos because of the type of material, its appearance and markings. When discarded building materials which may contain Asbestos are treated as general rubbish this constitutes improper disposal and represents a significant personal and environmental health risk.

A sample for lab analysis to confirm the presence of asbestos wasn't taken from this location. The client is advised to assume the affected area and construction material contains Asbestos until the lab analysis results are available. If the materials are confirmed as Asbestos the debris should be removed and the site cleaned by a Licensed Asbestos Removal firm. In the interim appropriate risk reduction strategies include isolating the area and ensuring the debris or rubbish is not further disturbed.

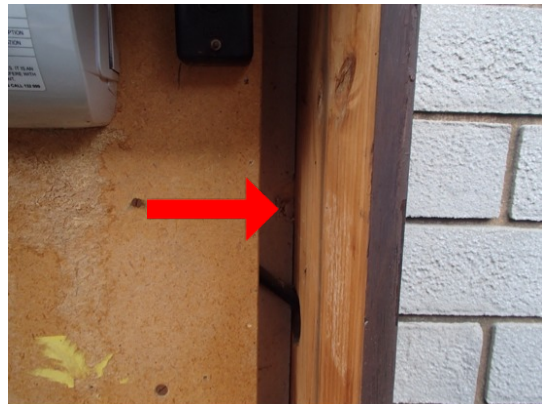
Asbestos, Asbestos Containing Materials and Asbestos Dust 4.04

Building:	Main Building
Location:	Exterior walls - left side
Finding:	Asbestos - ACM containing Switchboard backing
Information:	Samples of suspected Asbestos Containing Material (ACM) were removed from the building for analysis by a NATA accredited laboratory. The sample results confirmed that the material/s tested do contain Asbestos. The results indicated that the type of Asbestos is White Chrysotile. Consequently the client is advised to consider relevant risk reduction strategies including removal by a licensed Asbestos Removal firm.

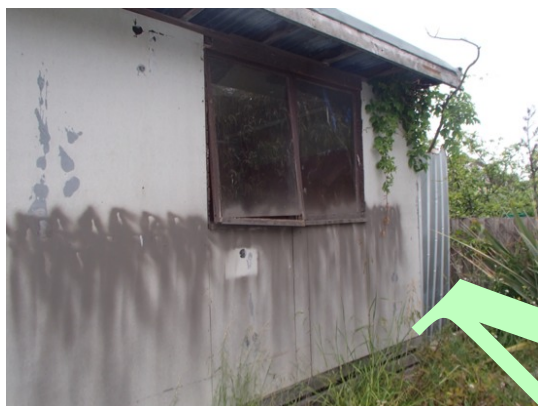
Asbestos, Asbestos Containing Materials and Asbestos Dust 4.05

Building:	Main Building
Location:	Shed
Finding:	Asbestos - ACM Confirmed - external walls
Information:	Samples of suspected Asbestos Containing Material (ACM) were removed from the building for analysis by a NATA accredited laboratory. The sample results confirmed that the material/s tested do contain Asbestos. The results indicated that the type of Asbestos is White Chrysotile. Consequently the client is advised to consider relevant risk reduction strategies including removal by a licensed Asbestos Removal firm.

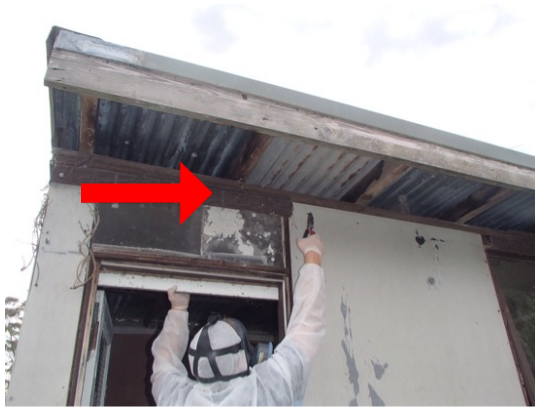
Asbestos, Asbestos Containing Materials and Asbestos Dust 4.06

Building:	Main Building
Location:	Shed
Finding:	Asbestos - ACM Confirmed - Fake brick cladding
Information:	Samples of suspected Asbestos Containing Material (ACM) were removed from the building for analysis by a NATA accredited laboratory. The sample results confirmed that the material/s tested do contain Asbestos. The results indicated that the type of Asbestos is White Chrysotile. Consequently the client is advised to consider relevant risk reduction strategies including removal by a licensed Asbestos Removal firm.

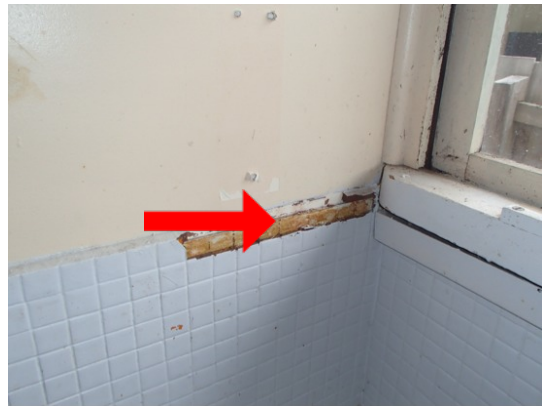
Asbestos, Asbestos Containing Materials and Asbestos Dust 4.07

Building:	Main Building
Location:	Kitchen and Laundry
Finding:	Asbestos - ACM Containing sheeting behind tiles
Information:	Samples of suspected Asbestos Containing Material (ACM) were removed from the building for analysis by a NATA accredited laboratory. The sample results confirmed that the material/s tested do contain Asbestos. The results indicated that the type of Asbestos is White Chrysotile. Consequently the client is advised to consider relevant risk reduction strategies including removal by a licensed Asbestos Removal firm.

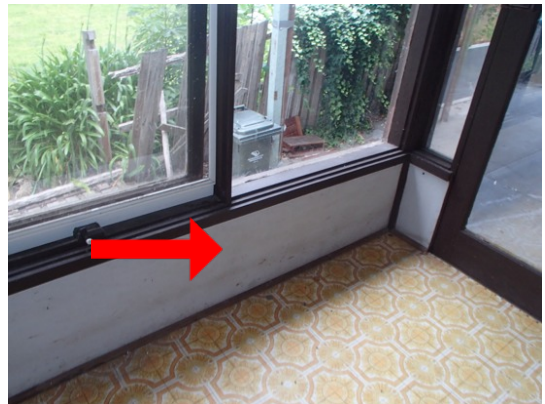
Asbestos, Asbestos Containing Materials and Asbestos Dust 4.09

Building:	Main Building
Location:	Sunroom
Finding:	Asbestos - ACM containing walls to sunroom, internally and externally
Information:	Samples of suspected Asbestos Containing Material (ACM) were removed from the building for analysis by a NATA accredited laboratory. The sample results confirmed that the material/s tested do contain Asbestos. The results indicated that the type of Asbestos is White Chrysotile. Consequently the client is advised to consider relevant risk reduction strategies including removal by a licensed Asbestos Removal firm.

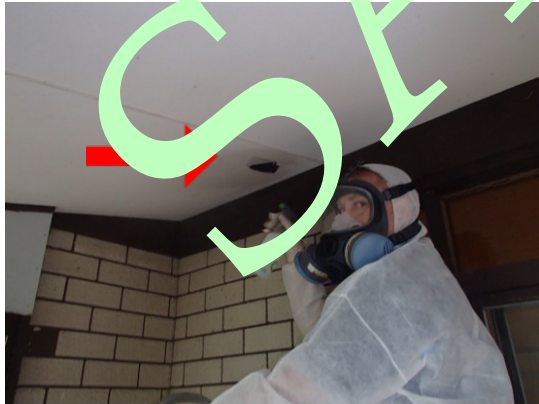
Asbestos, Asbestos Containing Materials and Asbestos Dust 4.1

Building: Main Building
Location: Sunroom
Finding: Asbestos - ACM Ceiling
Information: Samples of suspected Asbestos Containing Material (ACM) were removed from the building for analysis by a NATA accredited laboratory. The sample results confirmed that the material/s tested do contain Asbestos. The results indicated that the type of Asbestos is White Chrysotile. Consequently the client is advised to consider relevant risk reduction strategies including removal by a licensed Asbestos Removal firm.

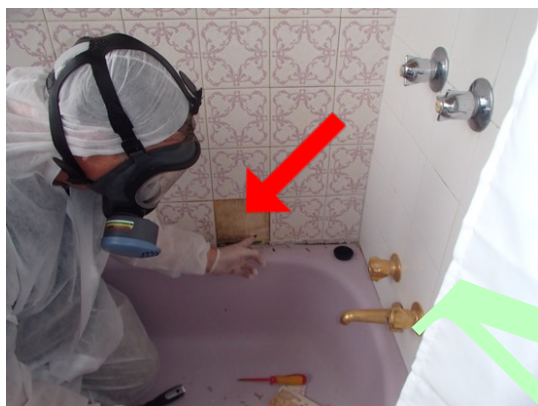
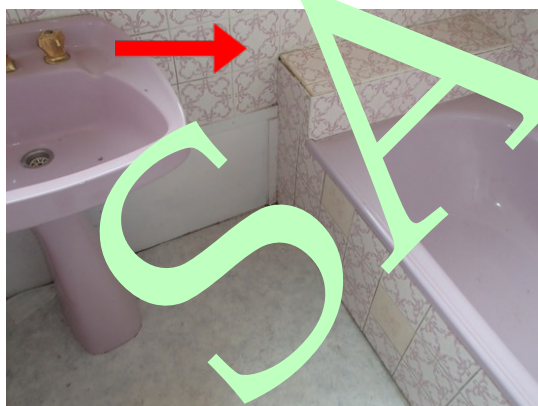
Asbestos, Asbestos Containing Materials and Asbestos Dust 4.11

Building: Main Building
 Location: Bathroom
 Finding: Asbestos - ACM Confirmed - sheeting behind tiles
 Information: Samples of suspected Asbestos Containing Material (ACM) were removed from the building for analysis by a NATA accredited laboratory. The sample results confirmed that the material/s tested do contain Asbestos. The results indicated that the type of Asbestos is white Chrysotile. Consequently the client is advised to consider relevant risk reduction strategies including removal by a licensed Asbestos Removal firm.

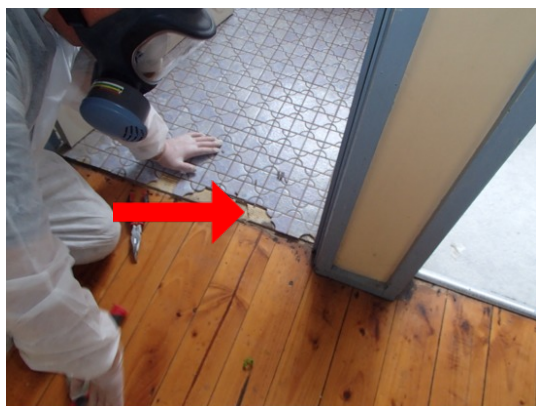
Asbestos, Asbestos Containing Materials and Asbestos Dust 4.12

Building: Main Building
 Location: Toilet (WC)

Finding:	Asbestos - ACM Confirmed - under floor tiles in toilet
Information:	Samples of suspected Asbestos Containing Material (ACM) were removed from the building for analysis by a NATA accredited laboratory. The sample results confirmed that the material/s tested do contain Asbestos. The results indicated that the type of asbestos is White Chrysotile. Consequently the client is advised to consider relevant risk reduction strategies including removal by a licensed Asbestos Removal firm.
