Dilapidation Inspection Report

Company Name: Jim's Building Inspections (Brighton)

Company Address and Postcode: Highett VIC 3190

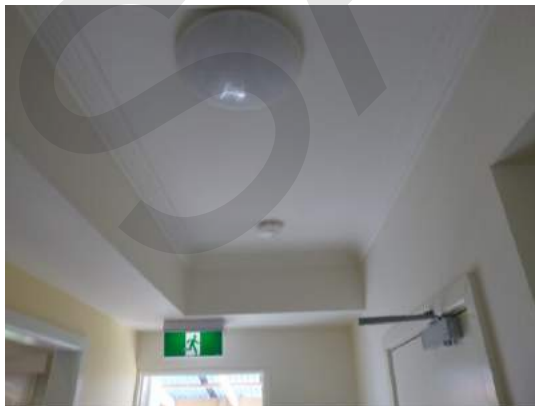
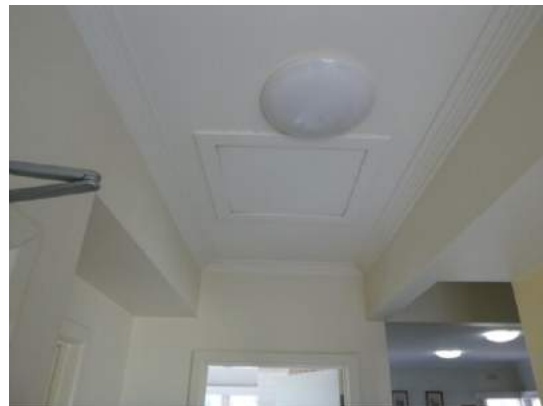
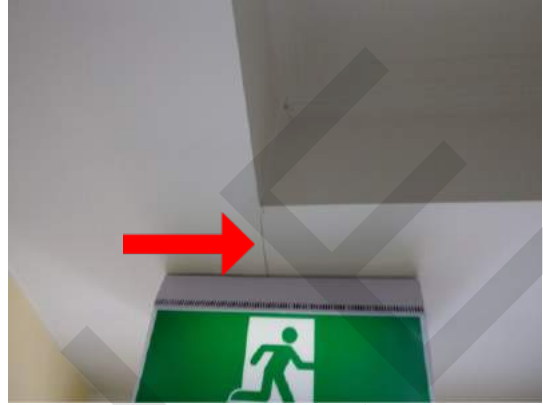
Defects 3.01

Building: Main Building
Location: Entry
Finding: Plaster - Cracking x2
Information: Cracking to the internal plaster was identified in this area at the time of inspection.

The plaster cracking is approximately up to 1mm wide by 250mm long at the time of inspection.

The plaster cracking is approximately up to 2mm wide by 400mm long at the time of inspection.

This cracking should be monitored frequently to identify whether further cracking results.

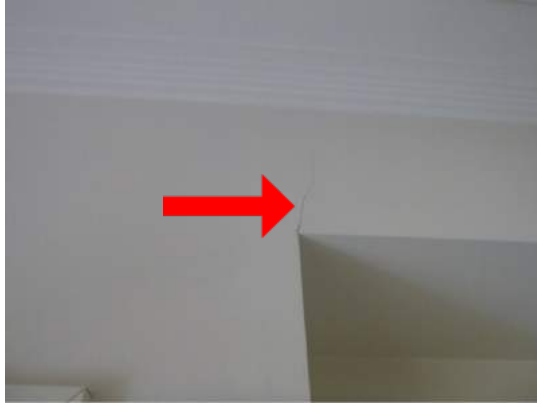
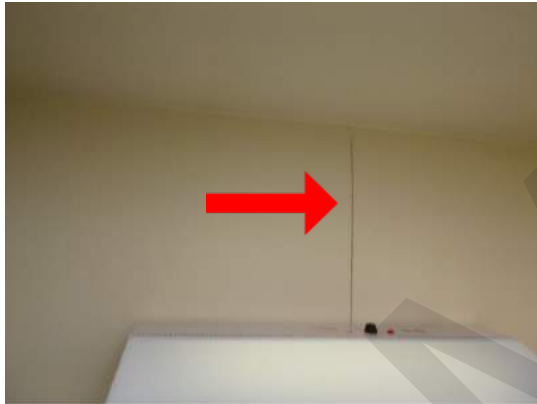
Defects 3.02

Finding: Plaster - Cracking x3

Information: Cracking to the internal plaster was identified in this area at the time of inspection.

The plaster cracking is approximately up to 2mm wide by 60mm long at the time of inspection.

The plaster cracking is approximately up to 2mm wide by 50mm long at the time of inspection.

This cracking should be monitored frequently to identify whether further cracking results.

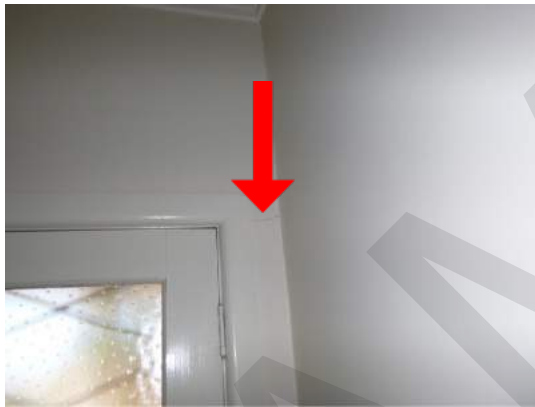
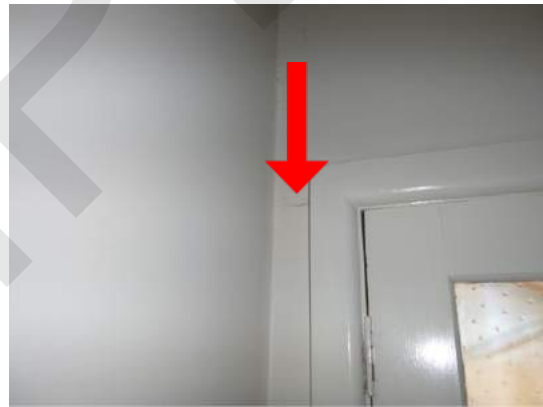
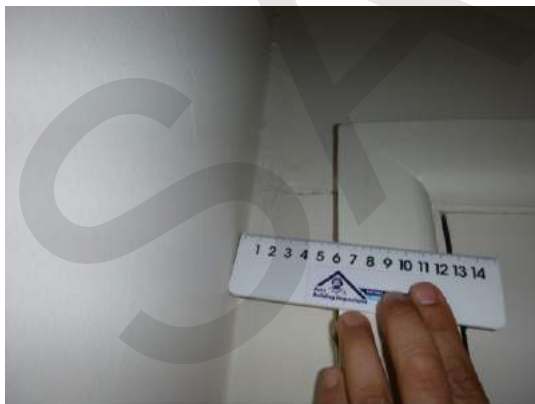
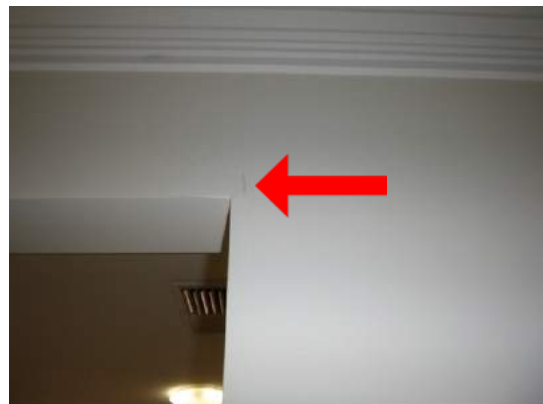
Building: Main Building

Location: Hallway

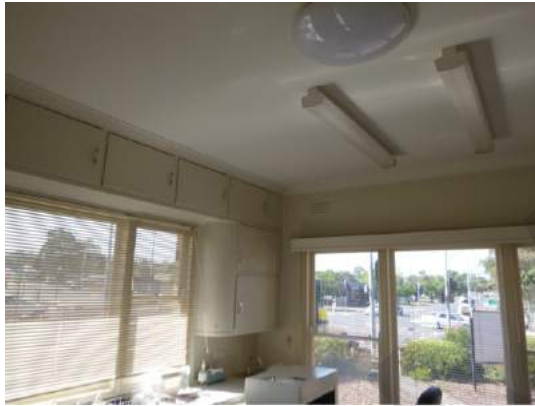
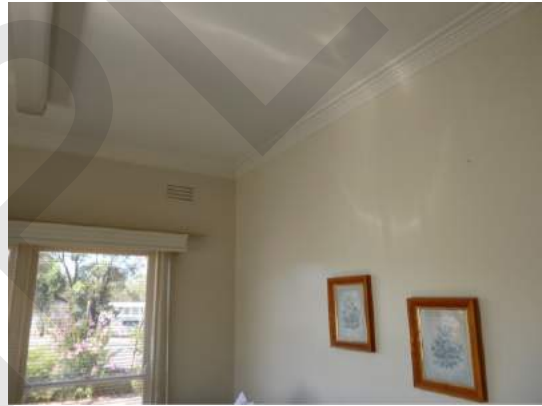
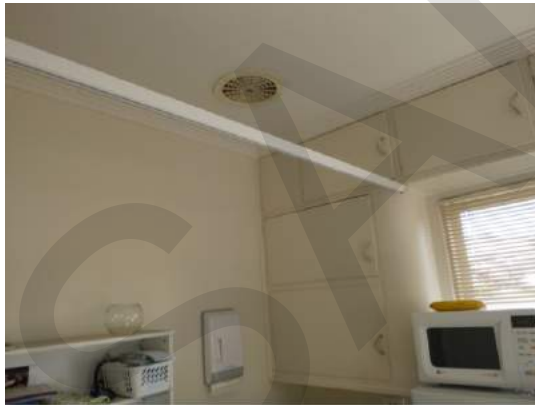
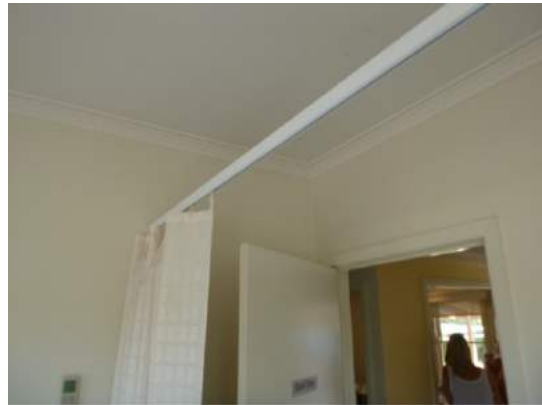
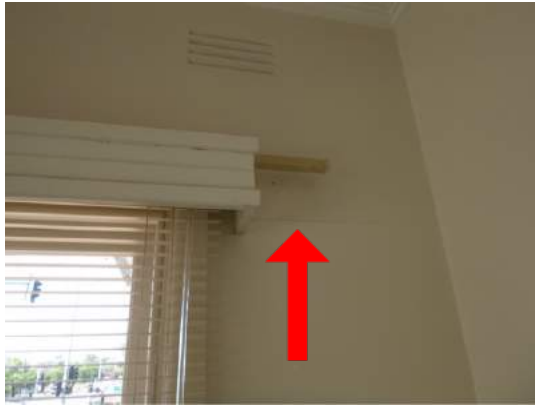
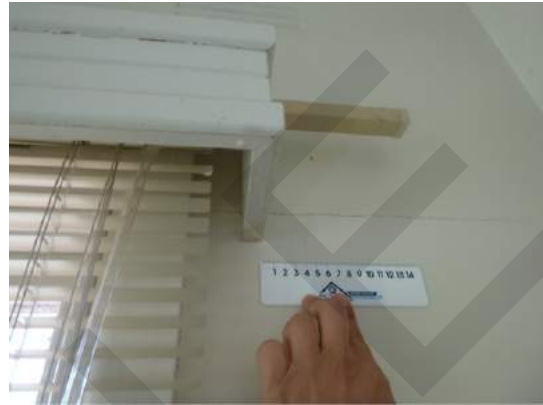
Defects 3.03

Building: Main Building
Location: Kitchen
Finding: Plaster - Cracking
Information: Cracking to the internal plaster was identified in this area at the time of inspection.

The plaster cracking is approximately up to 1mm wide by 300mm long at the time of inspection.

This cracking should be monitored frequently to identify whether further cracking results.

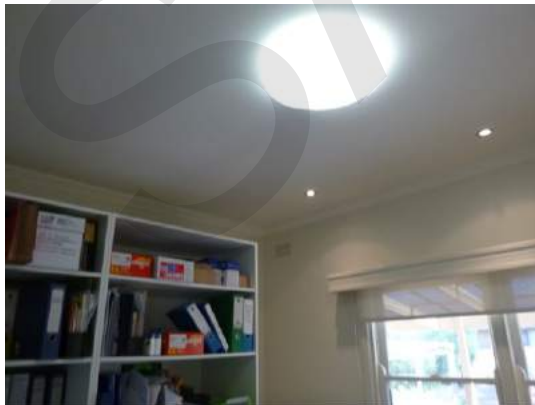
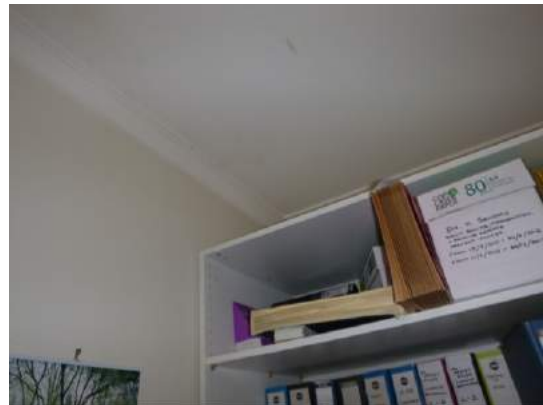
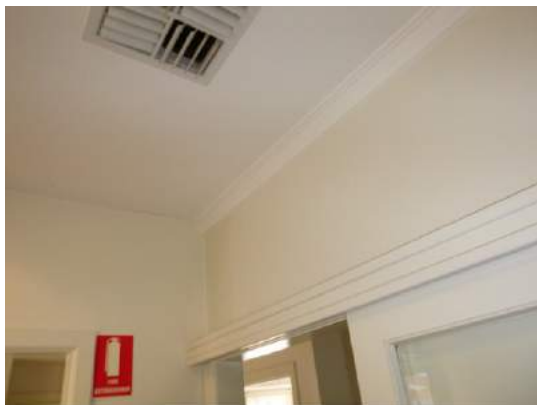
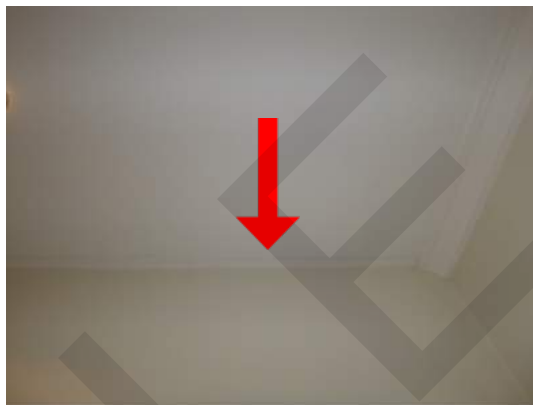
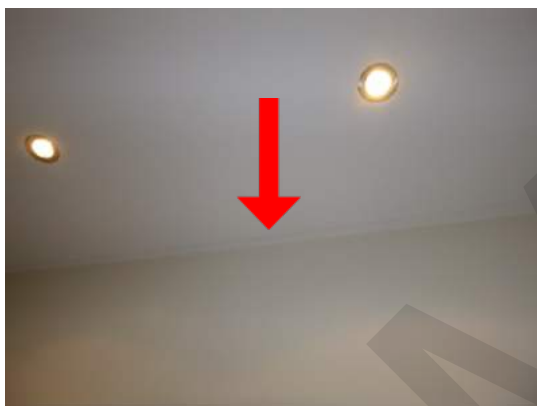
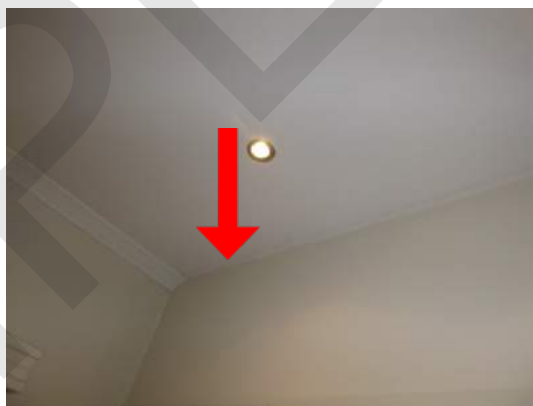
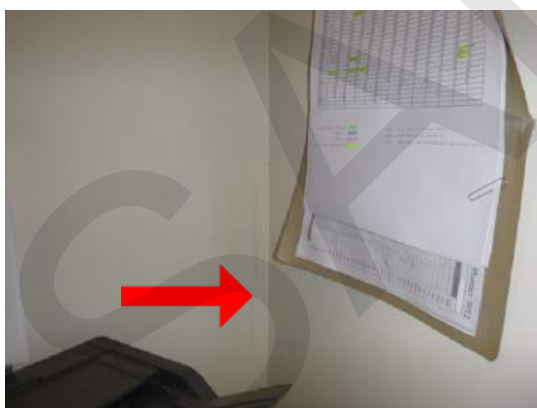
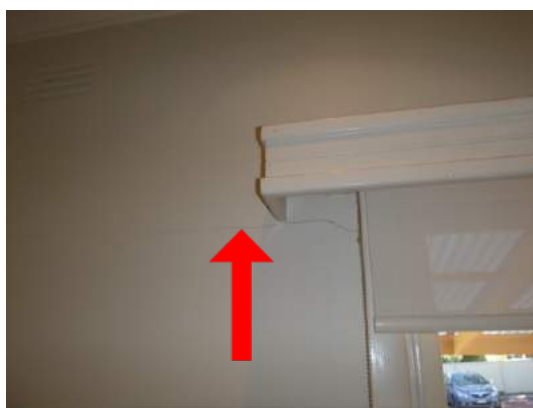
Defects 3.04

Building: Main Building
Location: Reception Office
Finding: Plaster - Cracking x3
Information: Cracking to the internal plaster was identified in this area at the time of inspection.

The plaster cracking is approximately up to 1mm wide by 2500mm long at the time of inspection.

The plaster cracking is approximately up to 2mm wide by 400mm long at the time of inspection.

The plaster cracking is approximately up to 1mm wide by 600mm long at the time of inspection.

This cracking should be monitored frequently to identify whether further cracking results.

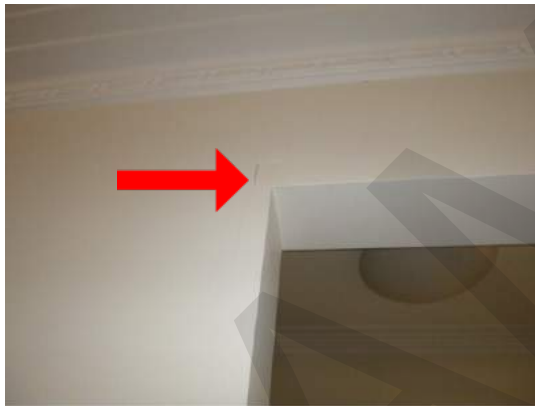
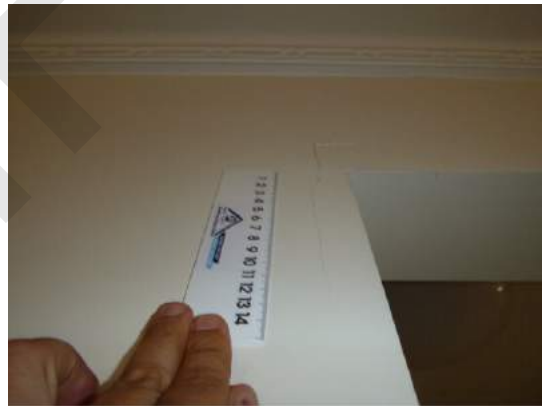
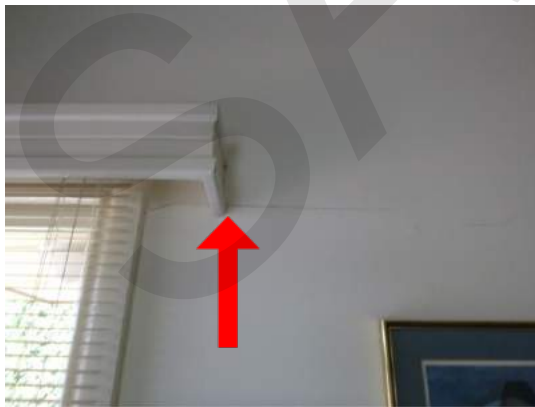
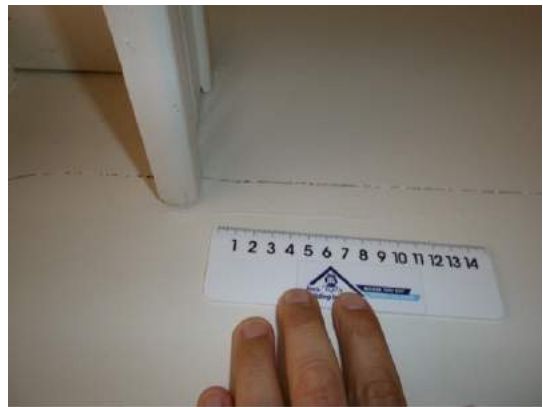
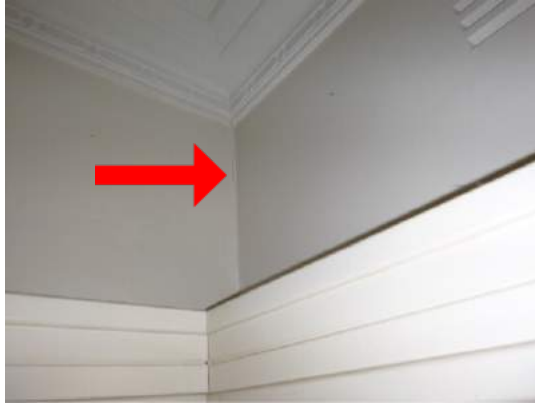
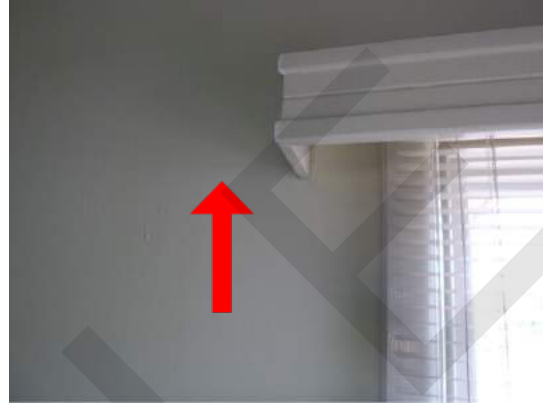
Defects 3.05

Building: Main Building
Location: Waiting Room
Finding: Plaster - Cracking x4
Information: Cracking to the internal plaster was identified in this area at the time of inspection.

The plaster cracking is approximately up to 1mm wide by 200mm long at the time of inspection.

The plaster cracking is approximately up to 1mm wide by 600mm long at the time of inspection.

The plaster cracking is approximately up to 1mm wide by 700mm long at the time of inspection.

The plaster cracking is approximately up to 1mm wide by 400mm long at the time of inspection.

This cracking should be monitored frequently to identify whether further cracking results.

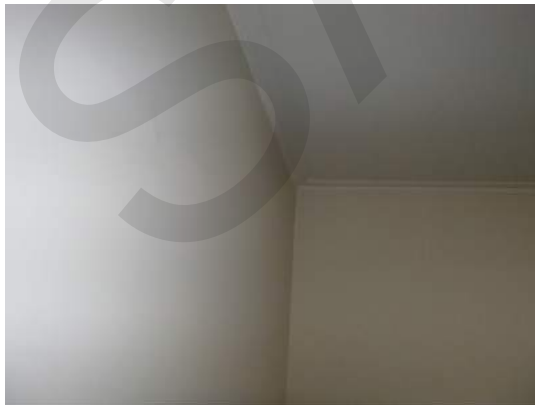
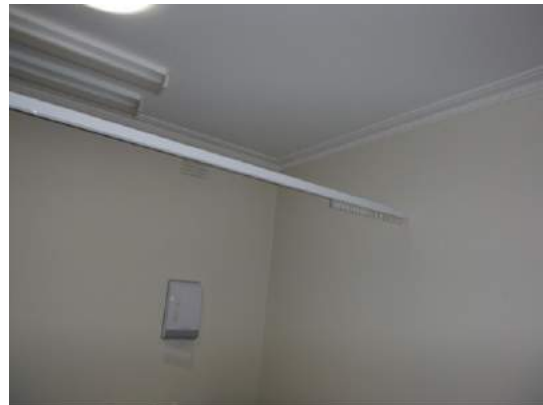
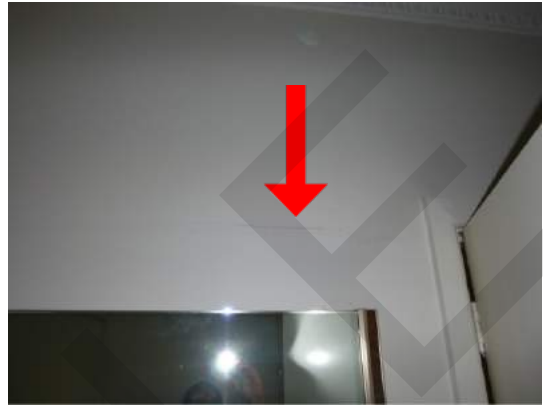
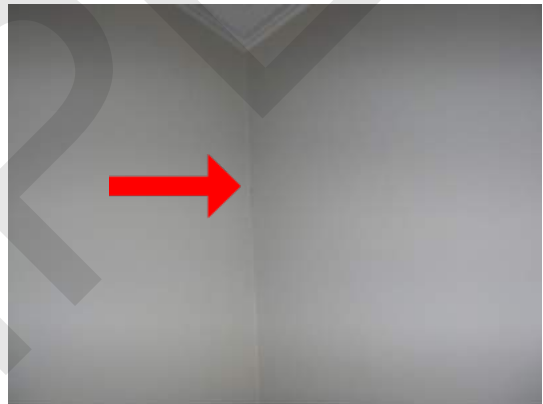
Defects 3.06

Building:	Main Building
Location:	Consulting Room 2
Finding:	Plaster - Cracking x3
Information:	Cracking to the internal plaster was identified in this area at the time of inspection.

The plaster cracking is approximately up to 1mm wide by 700mm long at the time of inspection.

The plaster cracking is approximately up to 2mm wide by 1200mm long at the time of inspection.

The plaster cracking is approximately up to 1mm wide by 400mm long at the time of inspection.

This cracking should be monitored frequently to identify whether further cracking results.

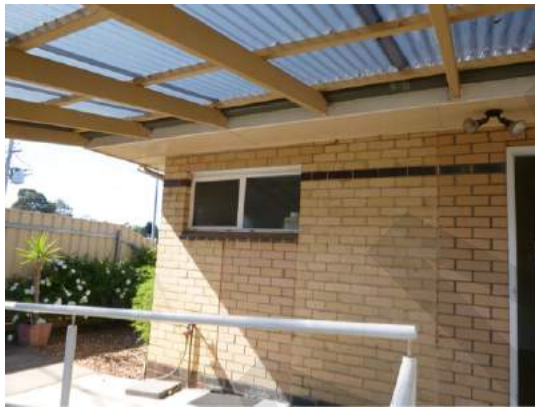
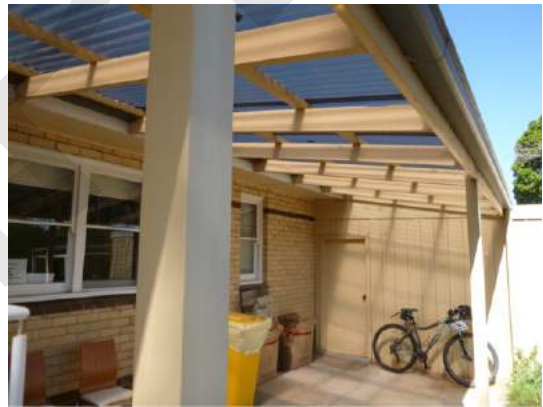
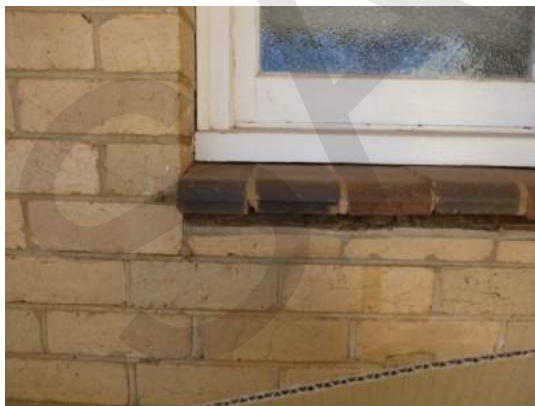
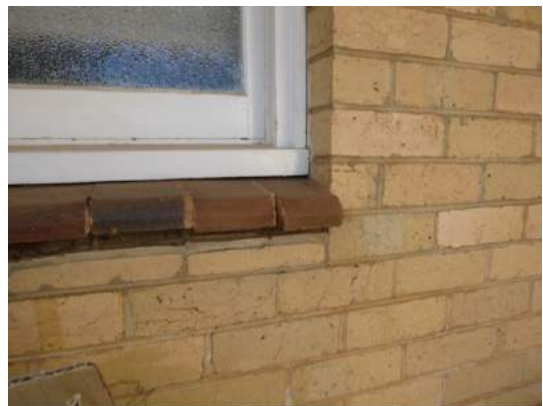
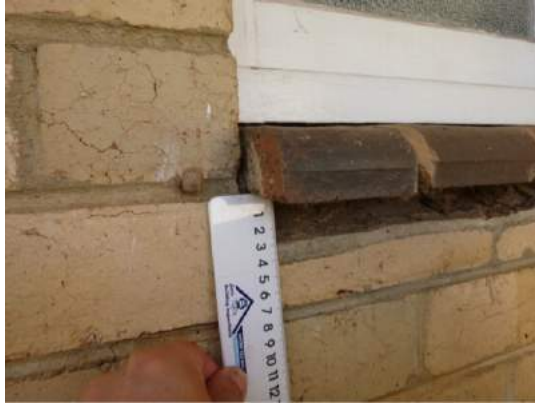
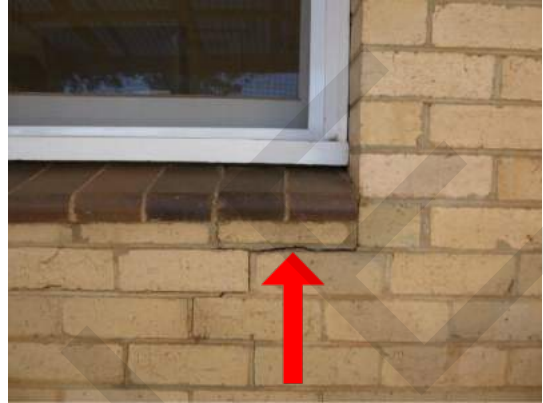
Defects 3.07

Building: Main Building
Location: Rear Elevation
Finding: Brickwork - Sill Bricks Lifted/Mortar Cracking
Information: Lifting of window sill bricks was identified in this area at the time of inspection.

Sill bricks were raised by approximately 30mm.

Mortar to one brick was cracked.

This should be carefully monitored to ensure that further lifting does not ensue as a result of further dilapidation.

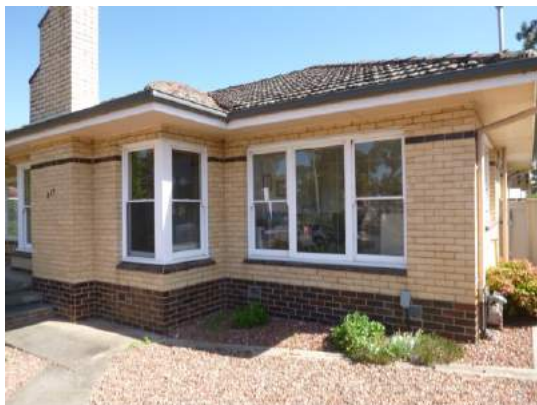
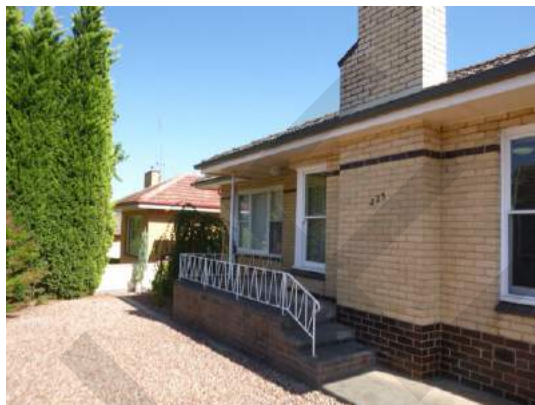
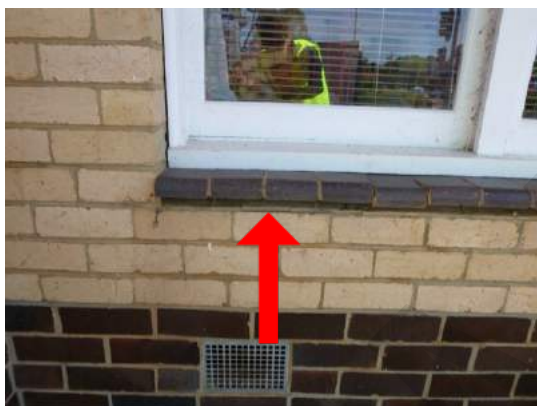
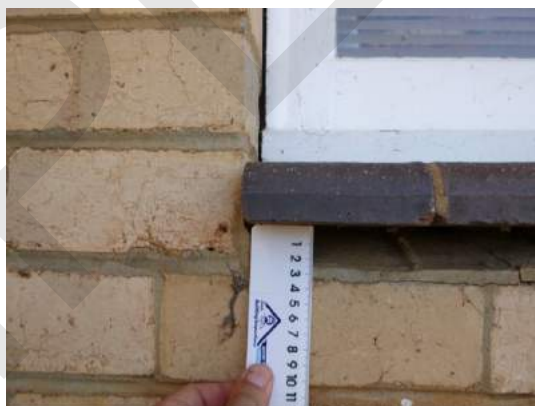
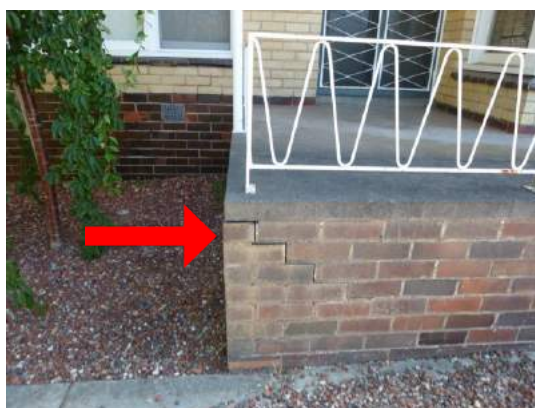
Defects 3.08

Step cracking was identified to the brickwork in two areas at the time of inspection.

Please refer to associated photographs for further detail.

Such cracking should be carefully inspected frequently to ensure that further cracking / deterioration does not ensue as a result of dilapidation.

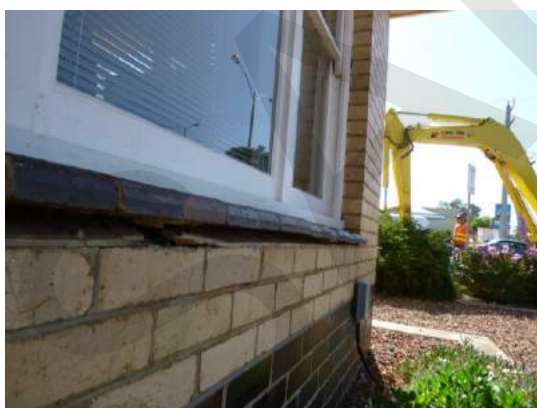
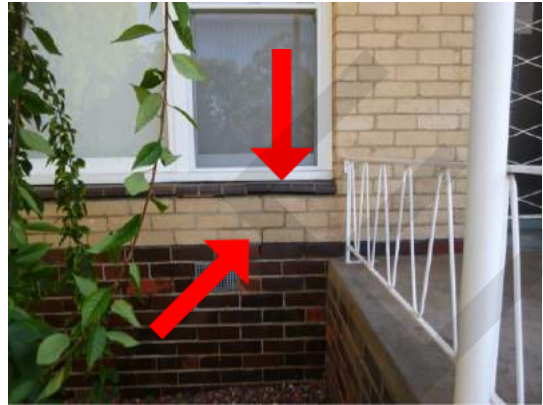
Building:	Main Building
Location:	Front Elevation
Finding:	Brickwork - Sill Bricks Lifted x2/Step Cracking x2
Information:	Lifting of window sill bricks was identified in two areas at the time of inspection.

Sill bricks were raised by approximately 30mm.

This should be carefully monitored to ensure that further lifting does not ensue as a result of further dilapidation.

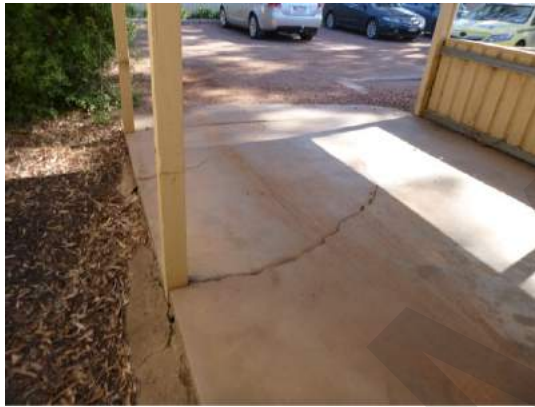
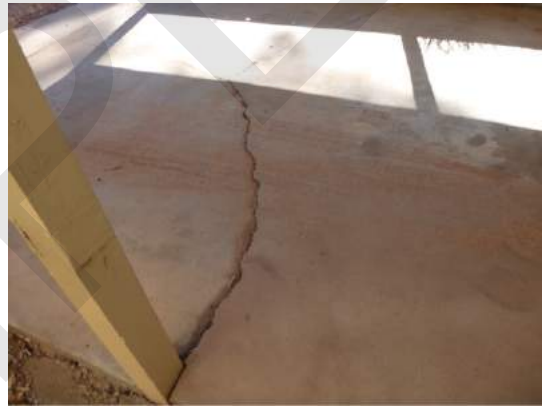
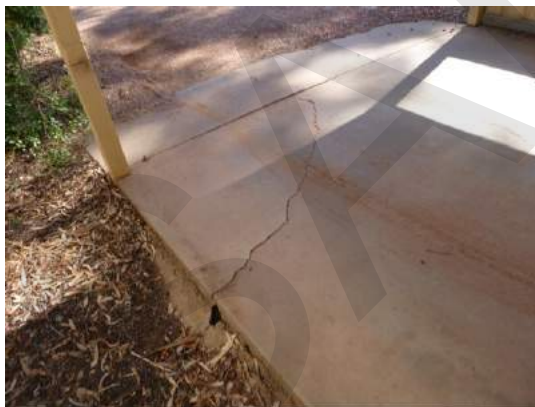
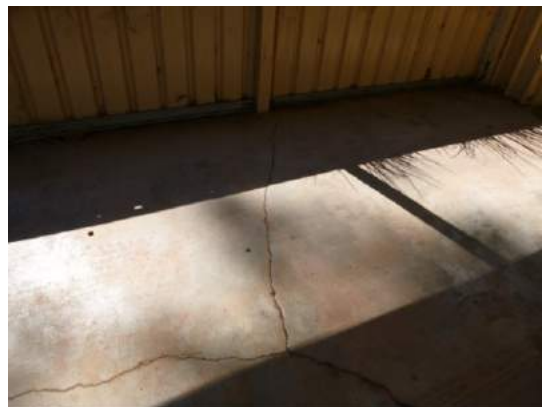
Defects 3.09

Building: Yard
Location: Yard - Rear Driveway to Garage
Finding: Concrete Paving - Cracking & Subsiding
Information: Cracking to the paving in this area was identified at the time of inspection.

This type of cracking is often consistent with general dilapidation of the property, and may continue to develop if left unmaintained.

Please refer to associated photographs for further detail. Frequent monitoring should be carried out to identify any further damage.

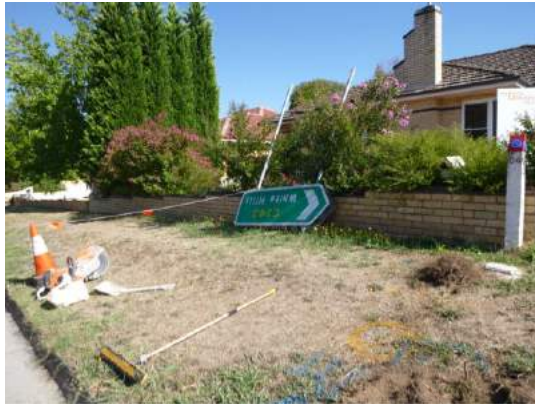
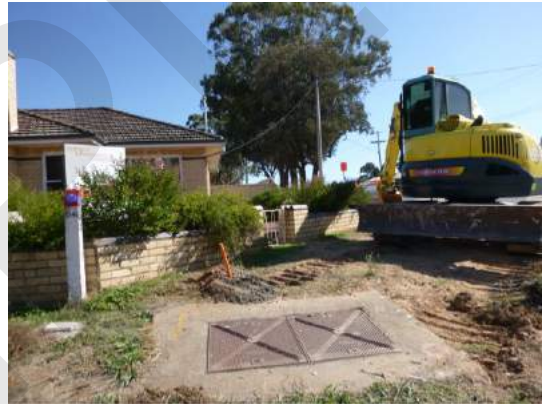
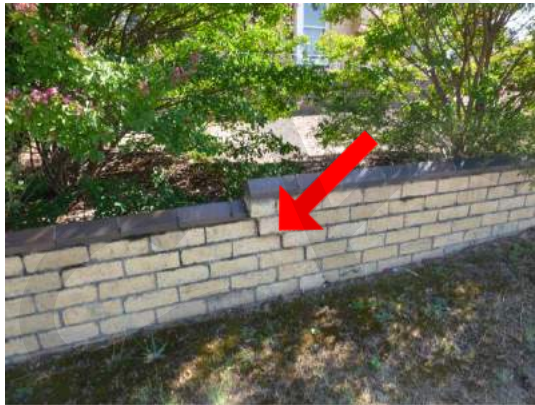
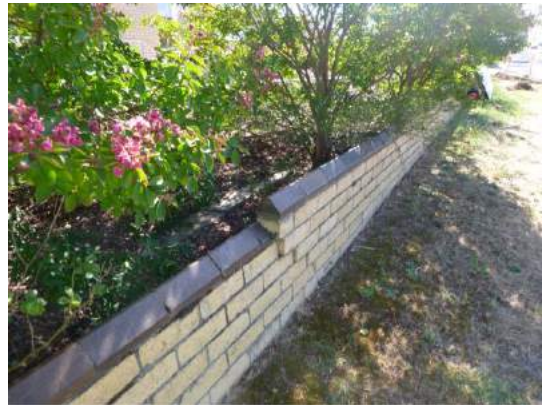
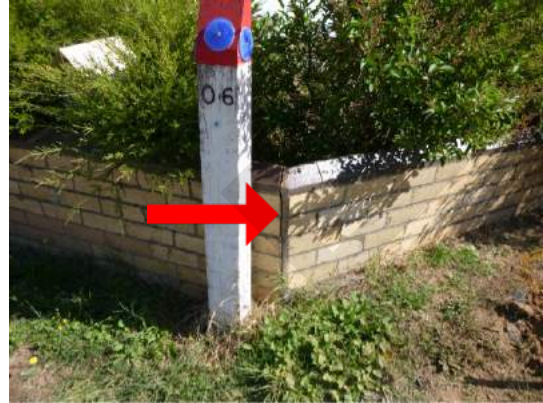
Defects 3.1

Building: Yard
Location: Front Brick Fencing
Finding: Brickwork - Cracking x3
Information: Cracking was identified to the brickwork in this area at the time of inspection.

This cracking should be carefully monitored to ensure that further cracking does not ensue as a result of further dilapidation.

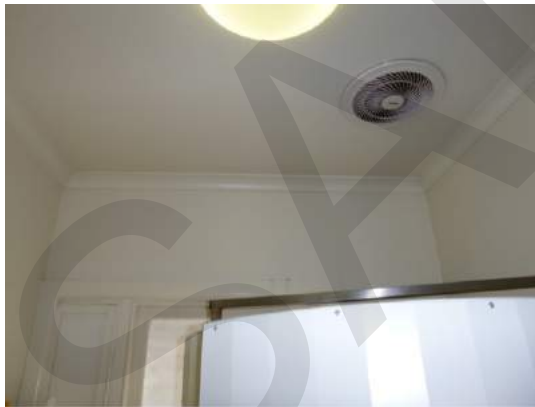
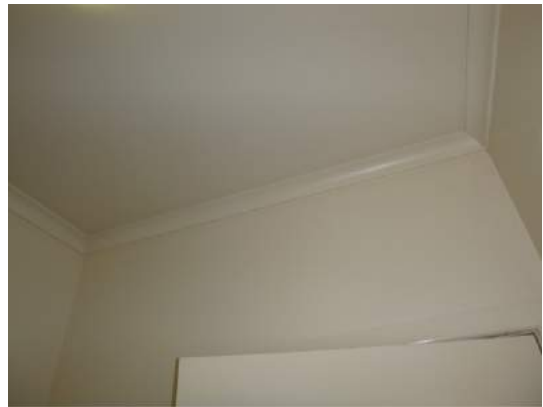
Building: Main Building
Location: UVB Therapy Room
Finding: No Visible Defects
Information: At the time of inspection, no visible defects as a result of dilapidation were identified in this area.

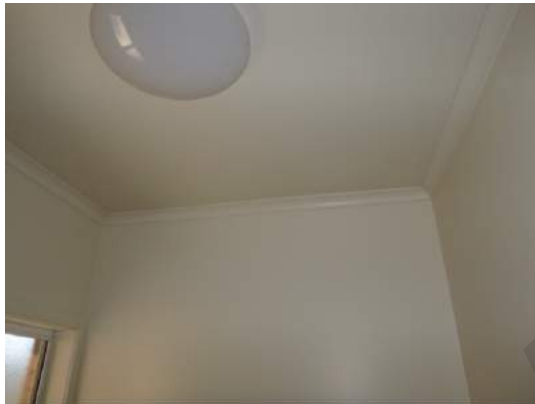
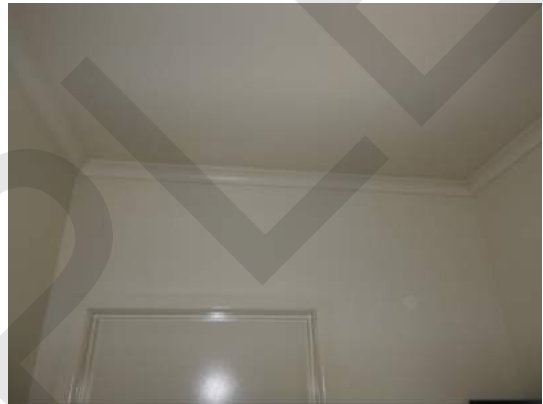
Building: Main Building
Location: Toilet (WC)
Finding: No Visible Defects
Information: At the time of inspection, no visible defects as a result of dilapidation were identified in this area.

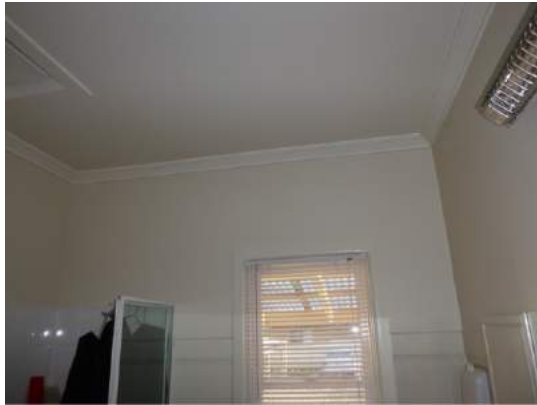
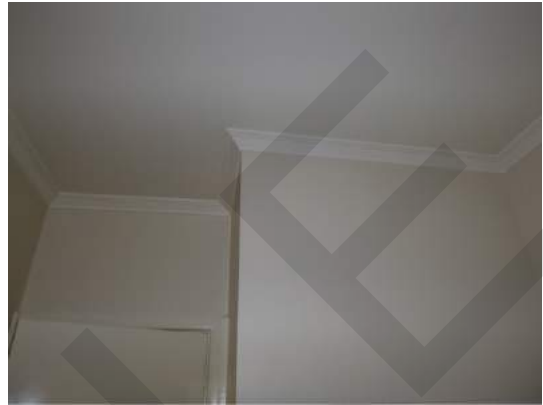
Building: Main Building
Location: Bathroom
Finding: No Visible Defects
Information: At the time of inspection, no visible defects as a result of dilapidation were identified in this area.

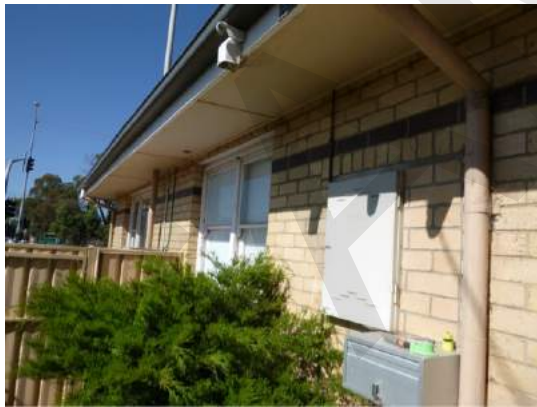
Building: Main Building
Location: Right Elevation
Finding: No Visible Defects
Information: At the time of inspection, no visible defects as a result of dilapidation were identified in this area.

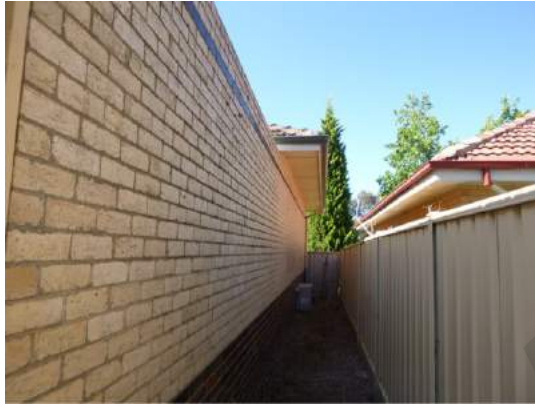
Building: Main Building
Location: Left Elevation
Finding: No Visible Defects
Information: At the time of inspection, no visible defects as a result of dilapidation were identified in this area.
