# New Construction Inspection - Handover Stage

Building Type:	Residential
Number of Storeys:	Single
Main building – floor construction:	Slab - Waffle Pod or Waffle Slab, Slab - Pier and Beam
Main building – wall construction:	Brick Veneer (Timber Framed)
Main building – roof construction:	Pitched, Timber Framed, Tiled
Other timber building elements:	Architraves, Door Frames, Doors, Internal Joinery, Skirting Boards, Floorboards
Other building elements:	Garage
Occupancy status:	Unoccupied
Furnished:	Unfurnished
Strata or company title properties:	No
Orientation (to establish the way the property was viewed):	West
Prevailing weather conditions at the time of inspection:	Overcast

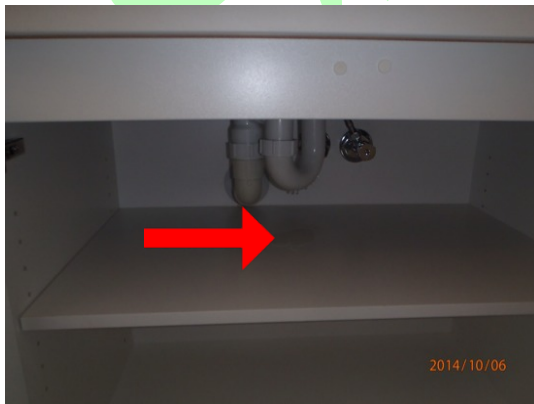
#### Defects 3.01

Building: Main Building  
Location: Ensuite  
Finding: Water leak - internal  
Information: Internal water leaks can be detrimental to surrounding building elements. Their potential causes include damage to plumbing fittings and fixtures through to deterioration of washers.

Rust corrosion decay and water damage are potential outcomes where an even minor water leak is left unattended. More serious defects may also result e.g.: electrical hazards.

In extreme cases structural damage may develop due to a prolonged water leak. It is highly advised that internal water leaks be addressed by a licensed plumber.

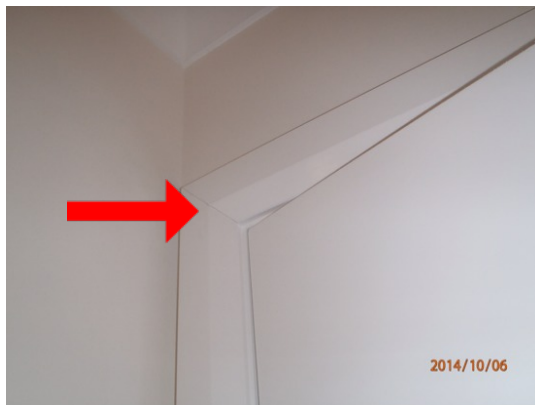
### Defects 3.02

Building:	Main Building
Location:	Bedroom - Master
Finding:	Cracking - Damage Category 1 - Fine (up to 1mm)
Information:	Although fine cracks are quite noticeable they are often only considered to be an appearance defect and usually do not indicate any structural damage. Generally the cause of a fine crack is indicative of a separation between building materials and finishes (e.g.: paint and plaster etc.) along joins.

Cracking of this nature can generally be repaired with minor sanding filling and/or repainting by a handy person or painting contractor.

Always contact a building inspector should cracks widen lengthen or become more numerous.

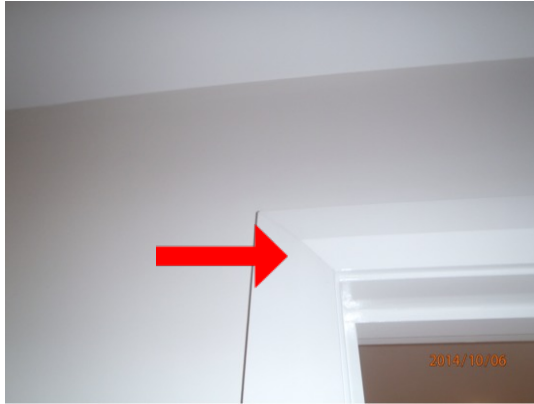
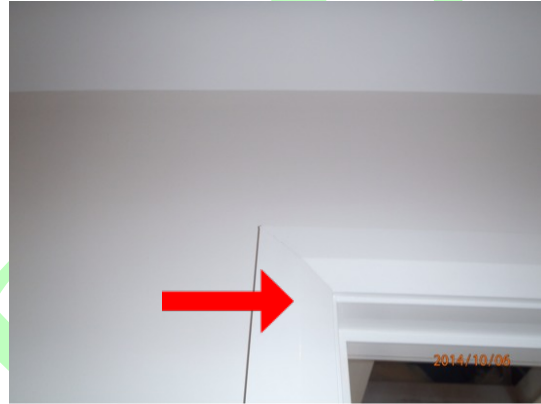
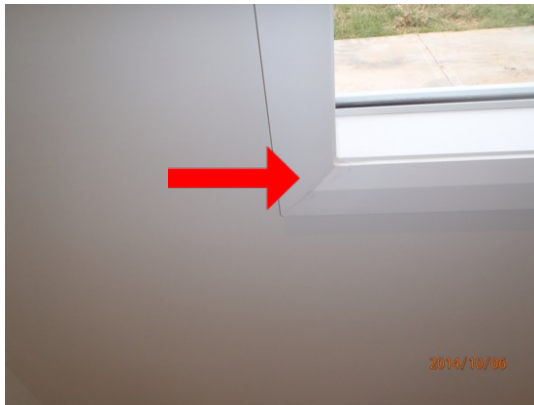
### Defects 3.03

Building:	Main Building
Location:	All Areas
Finding:	Cracking - Damage Category 1 - Fine (up to 1mm)
Information:	Although fine cracks are quite noticeable they are often only considered to be an appearance defect and usually do not indicate any structural damage. Generally the cause of a fine crack is indicative of a separation between building materials and finishes (e.g.: paint and plaster etc.) along joins.

Cracking of this nature can generally be repaired with minor sanding filling and/or repainting by a handy person or painting contractor.

Always contact a building inspector should cracks widen lengthen or become more numerous.

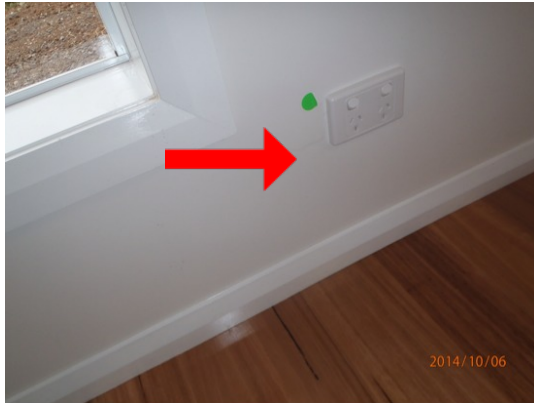
## Defects 3.04

Location: Bedroom 4

Finding: Plasterboard finish - defective

Information: The finish of the plasterboard in the identified area is defective as it falls below Level 4 category finish as defined in AS 2589.1 Section 6.6 Levels of Finishes for Plasterboard Surfaces. The key features of a Level 4 finish include: joints and fasteners adequately concealed joints and interior angles to have tape embedded in joint compound and at least 2 coats of joint compound to each joint angle fasteners accessories. A level 4 finish should be smooth and free of tool marks or Ridges

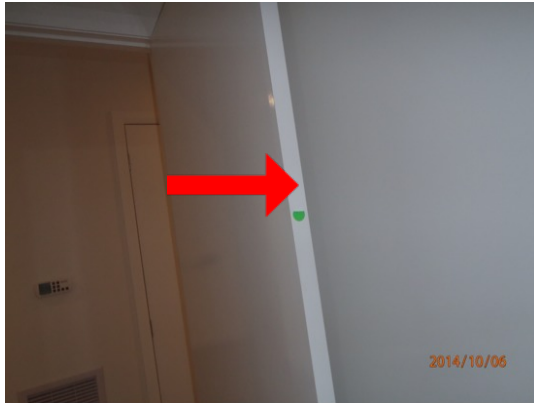
### Defects 3.05

Building:	Main Building
Location:	Bedroom 2
Finding:	Paint finish - substandard
Information:	<p>This is generally an appearance defect but may be indicative of poor surface preparation and substandard workmanship. If this applies further areas of poor and incomplete finishes could develop over time. Furthermore substandard paint finishes in areas exposed to moisture e.g. external areas or wet areas could lead to deterioration of underlying building materials.</p> <p>Substandard paint finishes should be sanded back filled levelled and repainted as applicable. Where inadequate paint protection has led to the deterioration of the associated building element repair and/or replacement of this building element may be required.</p> <p>A painting contractor should be appointed as soon as possible to perform necessary works to aid the appearance of the affected area and to ensure the area is protected against further deterioration. Alternatively the homeowner following manufacturers instructions may be able to provide this service.</p>

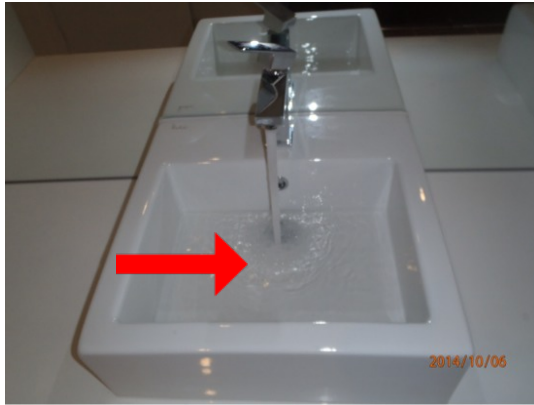
### Defects 4.01

Building:	Main Building
Location:	Bathroom
Finding:	Basin - blocked
Information:	The basin in this area appeared to be blocked upon inspection. Blockages prevent building elements from operating as intended and if left unmanaged a lack of general maintenance may lead to the development of more significant defects such as water damage to surrounding building materials.

It is advised the cause of the blockage be removed check for any secondary or concealed damage and then attempt to address the cause of the blockage to prevent any water damage to associated structures.

A licensed plumber should be appointed as soon as possible to remove the blockage and to perform any remedial works as necessary. Please be advised that a cabinet maker or qualified carpenter may be required if water damage is evident.

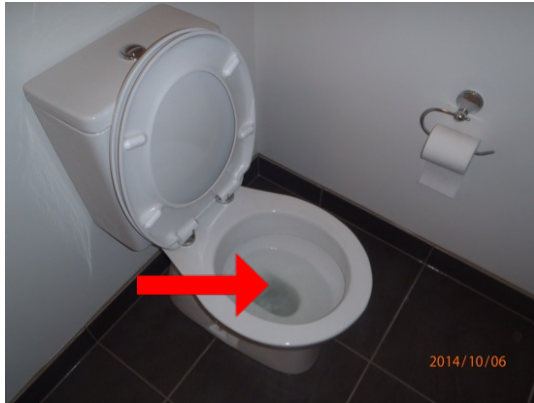
## Defects 4.02

Building: Main Building  
Location: Bathroom  
Finding: Blocked  
Information: Blockages prevent building elements from operating as intended and if left unmanaged the lack of general maintenance may lead to the development of more significant defects such as damage to surrounding building materials.

Blockages should be removed and addressed as they will lead to the development of secondary building defects. Remove the blockage check for any secondary or concealed damage and then attempt to address the cause of the blockage to prevent recurrence or any water damage to associated structures.

Depending on the location of the blockage and the building elements affected it is usually a Licensed Plumber that is the most suitable trade.

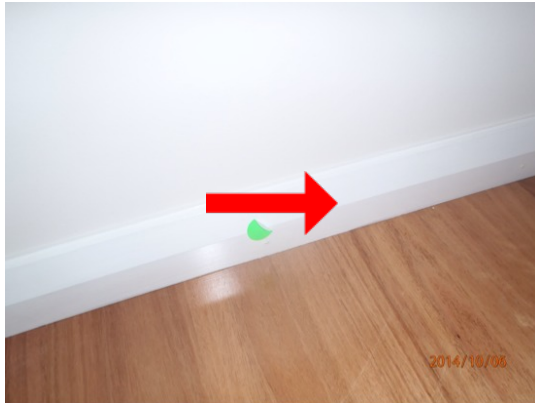
### Defects 4.03

Building:	Main Building
Location:	Bedroom 4
Finding:	Paint finish - incomplete or missing
Information:	<p>Whilst incomplete or missing paint finish is generally an appearance defect it can also lead to the development of secondary building defects over time. Incomplete areas of paint finish exposes the area to moisture which could lead to deterioration of underlying building materials.</p> <p>Incomplete paint finishes should be sanded back filled levelled and painted as applicable. Where inadequate or missing paint protection has led to the deterioration of the associated building element repair and/or replacement of this building element may be required.</p> <p>A painting contractor should be appointed as soon as possible to perform necessary works to aid the appearance of the affected area and to ensure the area is protected against further deterioration. Alternatively the homeowner following manufacturers instructions may be able to provide this service.</p>

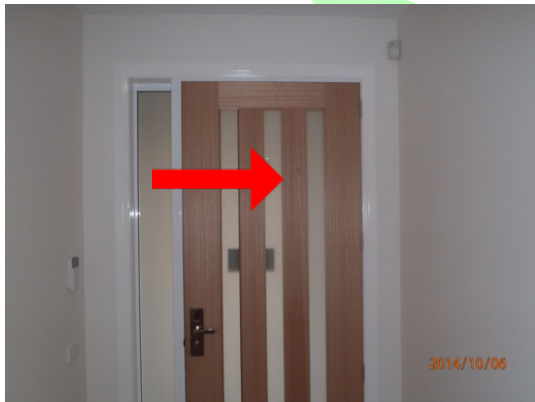
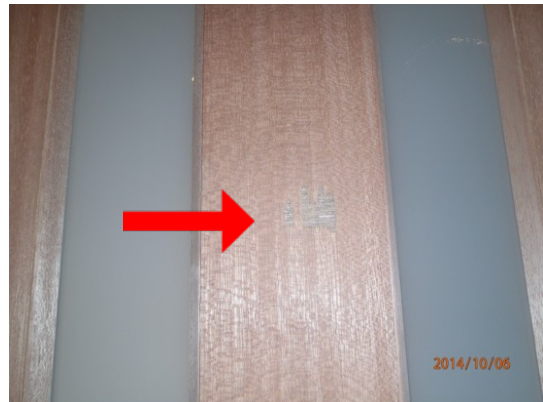
### Defects 4.04

Building: Main Building  
Location: Entry  
Finding: Damage front door  
Information: Evidence of damage was identified. To front door  
Timber veneer damaged supplier to replace

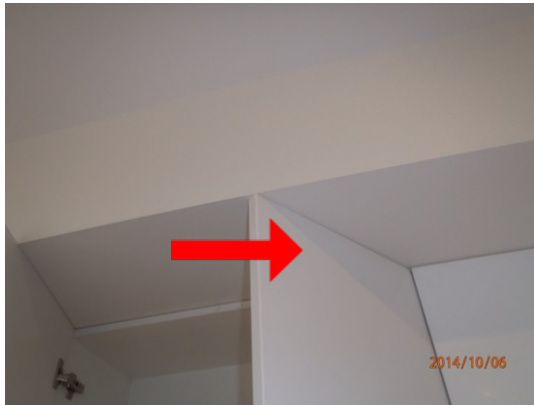
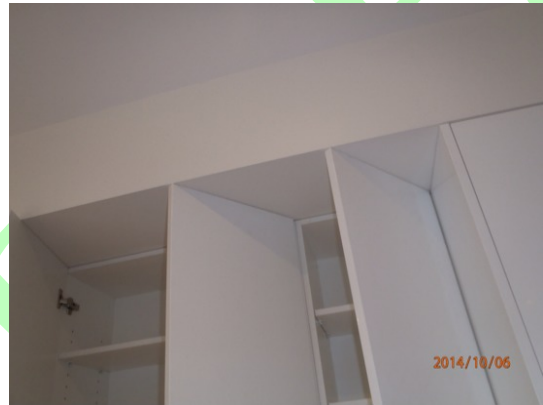
### Defects 4.05

Finding: Cabinet doors - misaligned  
Information: It is observed that some of the cabinet doors are not aligned and are rubbing on bulkhead  
Cabinet maker to adjust

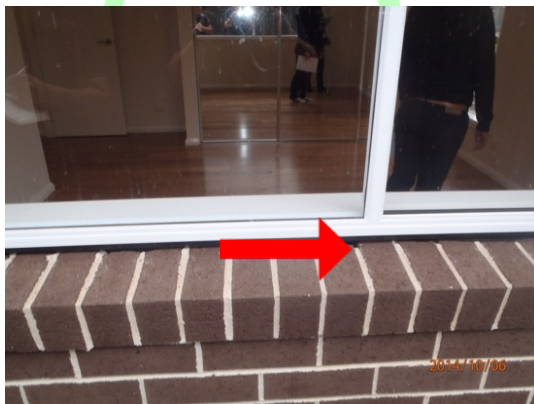
### Defects 4.06

Building: Main Building  
Location: Yard - Side  
Finding: Window installation not weather tight  
Information: It was observed that the window seal / or window frame installation is defective because it can possibly allow water to penetrate rooms under wet weather conditions.  
Builder to ensure all seals are complete and for a seal at the sill

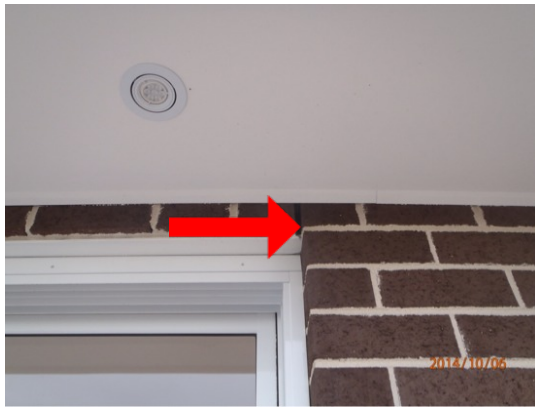
### Defects 4.07

Building:	Main Building
Location:	Yard - Side
Finding:	Sealing of masonry articulation joints - defective
Information:	It is observed that there areas of articulation joints in the masonry veneer without a cavity which are defective as they have not been sealed. It is a requirement of Standards and Tolerances that these joints be sealed.
