Asbestos Inspection and Condition Report (Sampling)

Original Inspection Date	Thu, 20 Nov 2014
Modified Date	Sat, 22 Nov 2014
Modified Date	Mon, 24 Nov 2014

Company Name: Jim's Building Inspections FSO (Sydney North)

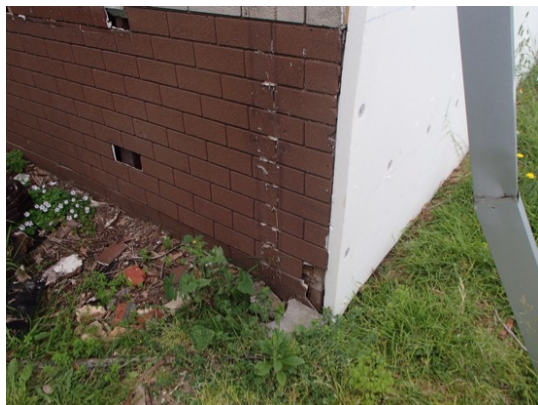
Asbestos, Asbestos Containing Materials and Asbestos Dust 2.03

Building:	Main Building
Location:	All External Areas
Finding:	ACM Suspected Artificial 'Fake Brick' Cladding - Grey
Information:	<p>Several forms of artificial or 'fake brick' cladding materials contain Asbestos. At the time of the inspection the observable areas of the cladding appear to be free of damage and deterioration.</p> <p>However, any subsequent point e.g. subsequent external fixing or the use of tools to apply or install anything onto the cladding and even minor impact damage or deterioration has the potential to release airborne asbestos fibres. Damaged and deteriorated ACMs have a higher probability of releasing airborne asbestos fibres creating a significant health safety risk.</p> <p>A sample for lab analysis to confirm the presence of asbestos was taken from this location. The client is advised to assume the affected area and construction material contains Asbestos until the lab analysis results are available.</p> <p>Given the entire property is clad in the material avoidance and isolation of the material is generally impracticable. However any unnecessary contact and certainly any works such as the use of tools to affix anything to the building should be avoided until lab analysis results are available.</p> <p>Removal by a Licensed Asbestos Removal firm would be advised. Where the client elects to retain the ACM the client should regularly monitor (at least annually but more frequently should damage or evidence of deterioration occur) the condition of the cladding material to identify any further damage or deterioration. This is particularly important where the cladding is present in highly traffic-able areas such as doorways or adjacent to fixings.</p>

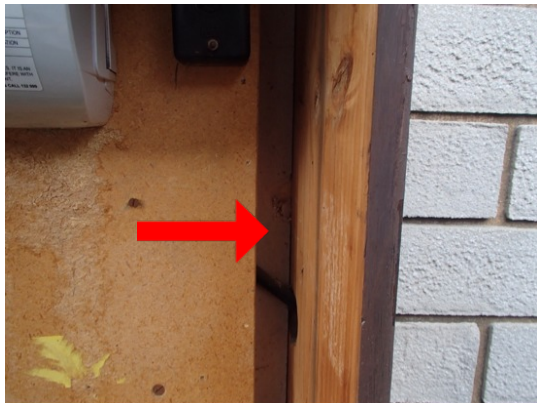
Asbestos, Asbestos Containing Materials and Asbestos Dust 2.05

Building:	Main Building
Location:	Exterior walls - left side
Finding:	ACM Suspected Damage leading to switchboard
Information:	<p>The sheeting to the door to the electrical switchboard is suspected to have been constructed with the use of asbestos-containing materials (ACM). The observable areas of sheeting appears to have no obvious signs of damage or deterioration indicating that the asbestos is currently encapsulated and contained. Damaged and deteriorated ACMs have a higher probability of releasing airborne asbestos fibres creating a significant health safety risk.</p> <p>A sample for lab analysis to confirm the presence of asbestos was taken from this location. The client is advised to assume the affected area and construction material contains Asbestos until the lab analysis results are available. The area should be avoided and no work should be undertaken on the area until lab analysis results are available. Removal by a Licensed Asbestos Removal firm would be advised. Where the client elects to retain the ACM the client should regularly monitor (at least annually but more frequently should damage or evidence of deterioration occur) the condition of the sheeting to identify any further damage or deterioration. Additional remedial work is a potential short to medium term solution to reduce the risk presented by the ACM.</p>

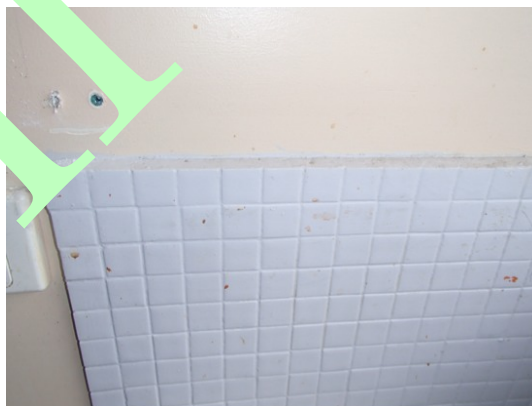
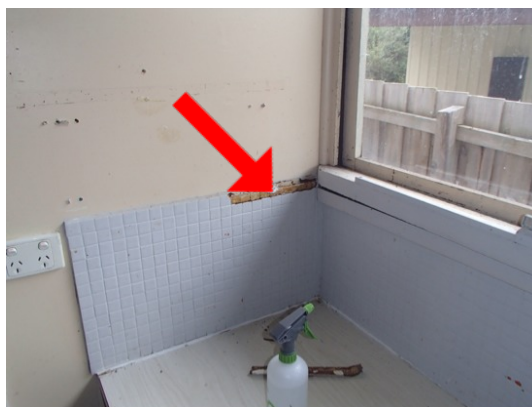
The sheet construction material behind the ceramic tiles in this area is suspected to be an asbestos containing material (ACM). Often found in bathrooms and kitchen environments in this construction context in buildings pre 1985.

The observable areas of sheeting appear to be bonded undamaged and free of deterioration. Damaged and deteriorated ACM's have a higher probability of releasing airborne asbestos fibres creating a significant health and safety risk.

A sample for lab analysis to confirm the presence of asbestos was taken from this location. The client is advised to assume the affected area and construction material contains Asbestos until the lab analysis results are available.

The area should be avoided and no works should be undertaken on the area until lab analysis results are available. Should Asbestos be confirmed the client should arrange for removal by a Licensed Asbestos Removal firm.

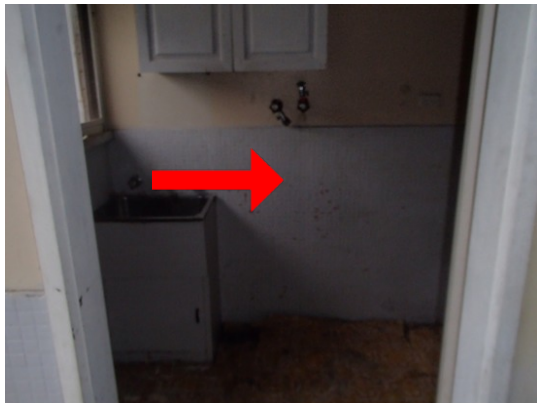
Asbestos, Asbestos Containing Materials and Asbestos Dust 2.09

Building: Main Building
 Location: Kitchen and Laundry and sunroom
 Finding: ACM Suspected vinyl floor covering
 Information: Vinyl floor covering may have several asbestos containing materials (ACM) including within the vinyl body of the sheeting or as a fibrous backing to the tiles or as an asbestos-based adhesive used to fix the tiles to the adjoining floor. At the time of the inspection the observed areas of vinyl flooring appear to be free of damage or deterioration. Damaged and deteriorated ACMs have a higher probability of releasing airborne asbestos fibres creating a significant health and safety risk.

A sample for lab analysis to confirm the presence of asbestos was taken from this location. The client is advised to assume the affected area and construction material contains Asbestos until the lab analysis results are available. The area should be avoided and no works should be undertaken on the area until lab analysis results are available. Removal by a Licensed Asbestos Removal firm would be advised. Where the client elects to retain the ACM the client should regularly monitor (at least annually but more frequently should damage or evidence of deterioration occur) the condition of the vinyl flooring to identify any further damage or deterioration. This is particularly important where the vinyl flooring is present in a trafficable or highly trafficable area.

No works should be carried out to the ACM or associated building elements without further specialist advice.

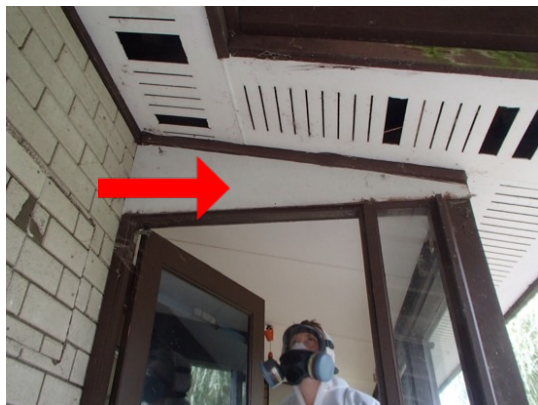
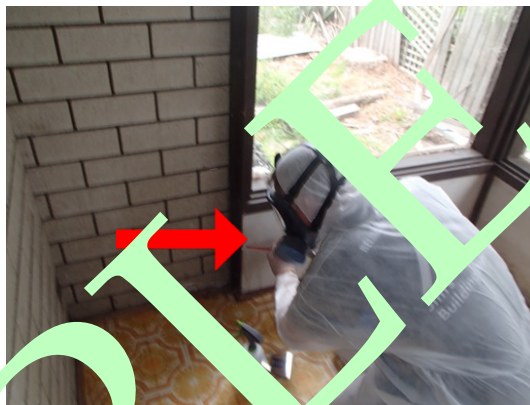
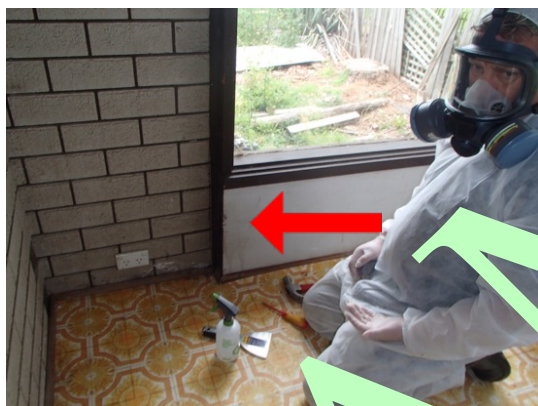
Asbestos, Asbestos Containing Materials and Asbestos Dust 2.11

Information: Ceilings to the sunroom appear to have been constructed with the use of asbestos-containing materials (ACM). The observable areas of the ceiling sheets were free of damage and deterioration which represents a lesser health and safety risk than if they were in a poor damaged or deteriorating condition.

ACM the client should regularly monitor (at least annually but more frequently should damage or evidence of deterioration occur) the condition of the ceiling sheets to identify any further damage or deterioration. Inspection should also cover factors that may lead to the deterioration of the ceilings such as minor roof leaks or structural movement. Additional remedial work is a potential short to medium term solution to reduce the risk presented by the ACM. Where possible the encapsulation of the asbestos materials using an appropriate sealant again by a specialist contractor can be considered.

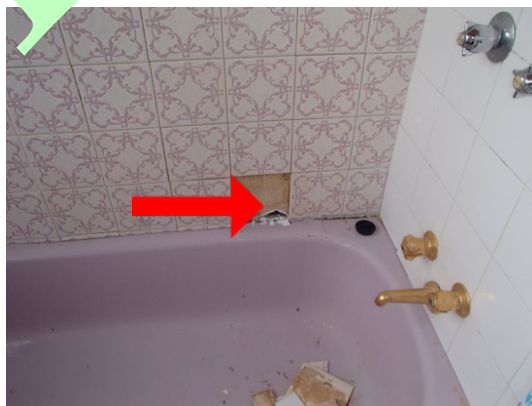
Information: The sheet construction material behind the ceramic tiles in this area is suspected to be an asbestos containing material (ACM). Often found in bathrooms and kitchen environments in this construction context in buildings pre 1985. The observable areas of sheeting appear to be bonded and damaged and free of deterioration. Damaged and deteriorated ACM's have a higher probability of releasing airborne asbestos fibres creating a significant health and safety risk.

A sample for lab analysis to confirm the presence of asbestos was taken from this location. The client is advised to assume the affected area and construction material contains Asbestos until the lab analysis results are available.

The area should be avoided and no works should be undertaken on the area until lab analysis results are available. Should asbestos be confirmed the client should arrange for removal by a Licensed Asbestos Removal firm.

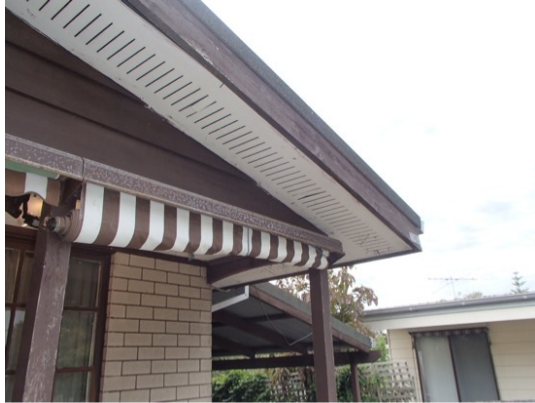
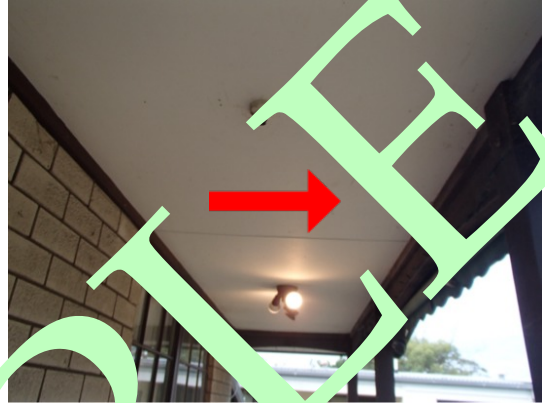
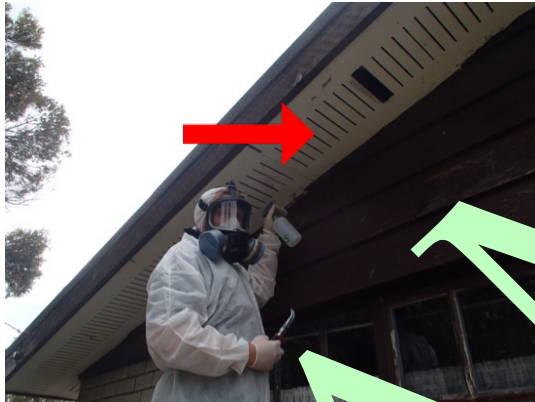
Asbestos, Asbestos Containing Materials and Asbestos Dust 4.02

Information: Samples of suspected Asbestos Containing Material (ACM) were removed from the building for analysis by a NATA accredited laboratory. The sample results confirmed that the material/s tested do contain Asbestos. The results indicated that the type of Asbestos is White Chrysotile and Brown Amosite. Consequently the client is advised to consider relevant risk reduction strategies including removal by a licensed Asbestos Removal firm.

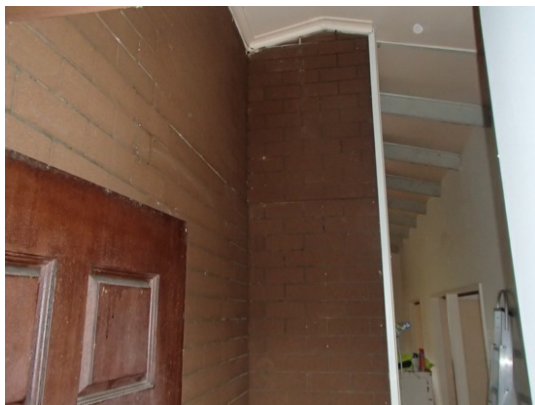
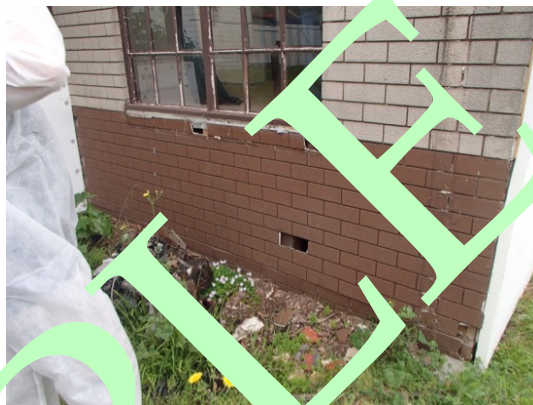
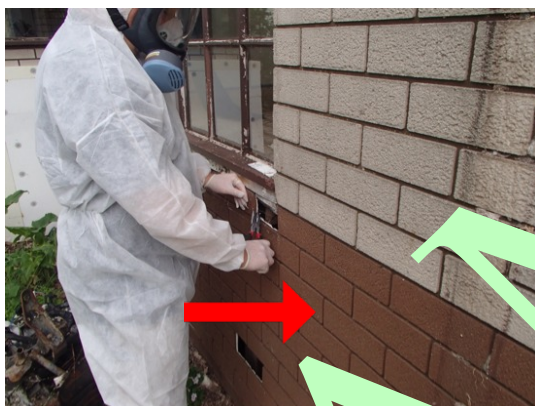
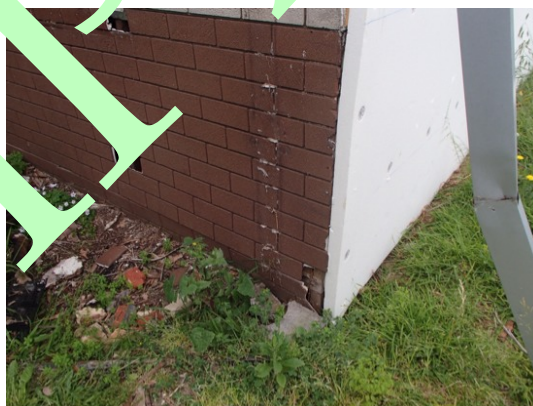
Asbestos, Asbestos Containing Materials and Asbestos Dust 4.03

Information: Samples of suspected Asbestos Containing Material (ACM) were removed from the building for analysis by a NATA accredited laboratory. The sample results confirmed that the material/s tested do contain Asbestos. The results indicated that the type of Asbestos is White Chrysotile. Consequently the client is advised to consider relevant risk reduction strategies including removal by a licensed Asbestos Removal firm.

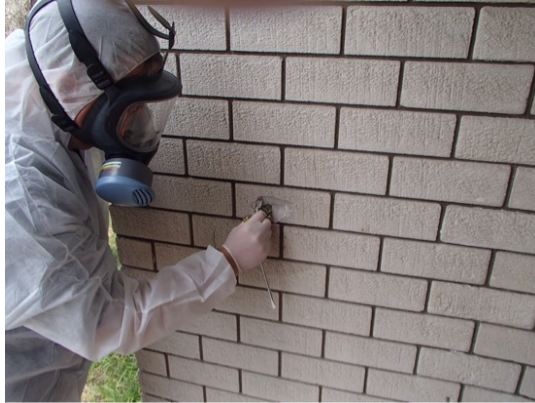
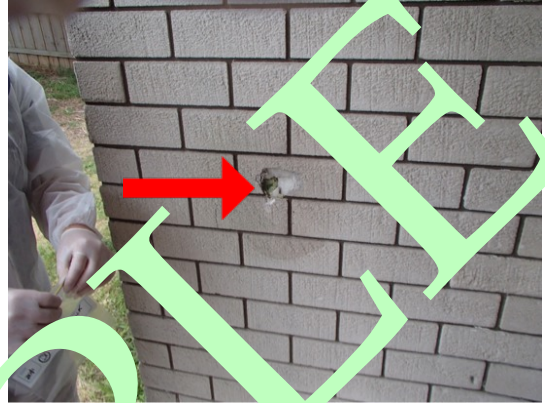
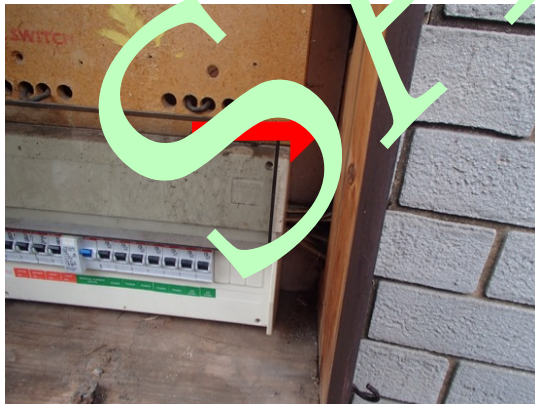
Asbestos, Asbestos Containing Materials and Asbestos Dust 4.04

Building:	Main Building
Location:	Exterior walls - left side
Finding:	Asbestos - ACM containing Switchboard backing
Information:	Samples of suspected Asbestos Containing Material (ACM) were removed from the building for analysis by a NATA accredited laboratory. The sample results confirmed that the material/s tested do contain Asbestos. The results indicated that the type of Asbestos is White Chrysotile. Consequently the client is advised to consider relevant risk reduction strategies including removal by a licensed Asbestos Removal firm.

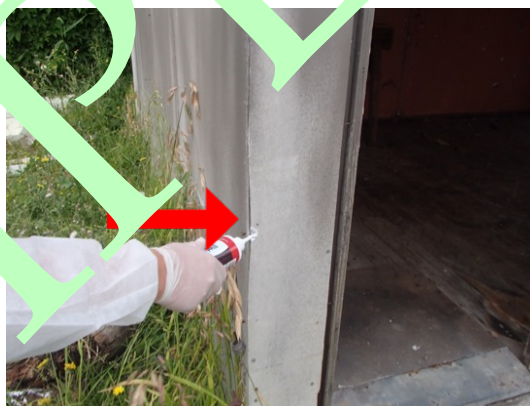
Asbestos, Asbestos Containing Materials and Asbestos Dust 4.06

Building:	Main Building
Location:	Shed
Finding:	Asbestos - ACM Confirmed - Fake brick cladding
Information:	Samples of suspected Asbestos Containing Material (ACM) were removed from the building for analysis by a NATA accredited laboratory. The sample results confirmed that the material/s tested do contain Asbestos. The results indicated that the type of Asbestos is White Chrysotile. Consequently the client is advised to consider relevant risk reduction strategies including removal by a licensed Asbestos Removal firm.

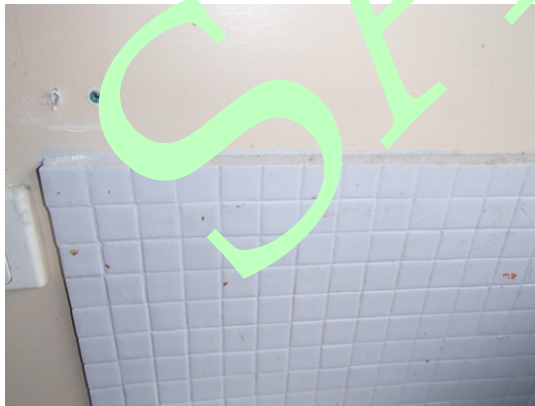
Asbestos, Asbestos Containing Materials and Asbestos Dust 4.07

Building:	Main Building
Location:	Kitchen and Laundry
Finding:	Asbestos - ACM Containing sheeting behind tiles
Information:	Samples of suspected Asbestos Containing Material (ACM) were removed from the building for analysis by a NATA accredited laboratory. The sample results confirmed that the material/s tested do contain Asbestos. The results indicated that the type of Asbestos is White Chrysotile. Consequently the client is advised to consider relevant risk reduction strategies including removal by a licensed Asbestos Removal firm.

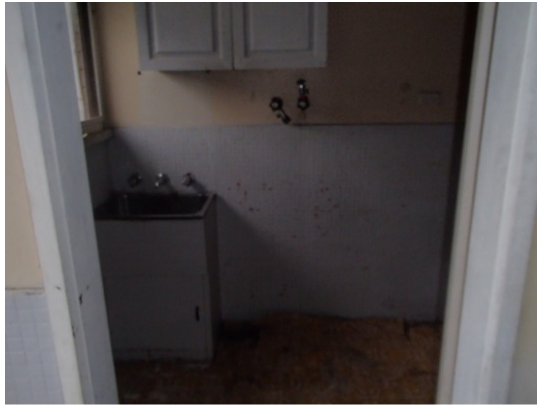
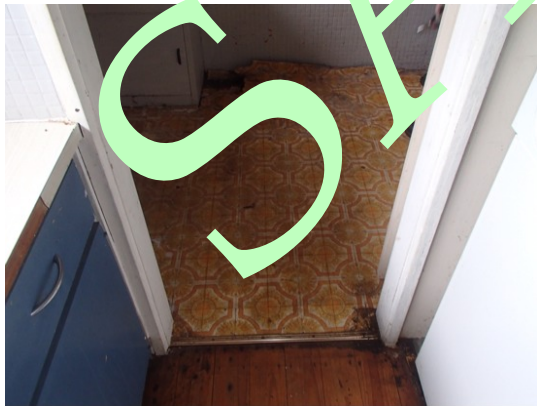
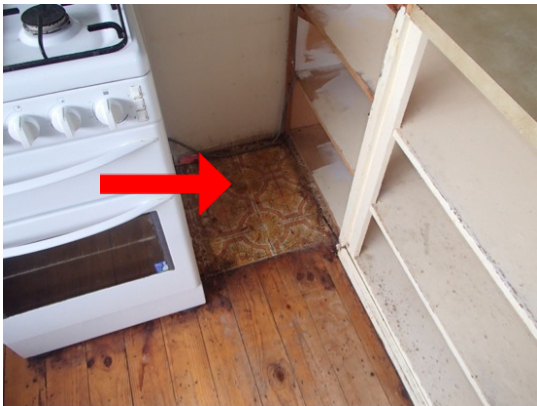
Asbestos, Asbestos Containing Materials and Asbestos Dust 4.08

Finding: Asbestos - ACM Ceiling, Vinyl flooring

Information: Samples of suspected Asbestos Containing Material (ACM) were removed from the building for analysis by a NATA accredited laboratory. The sample results confirmed that the material/s tested do contain Asbestos. The results indicated that the type of Asbestos is White Chrysotile. Consequently the client is advised to consider relevant risk reduction strategies including removal by a licensed Asbestos Removal firm.

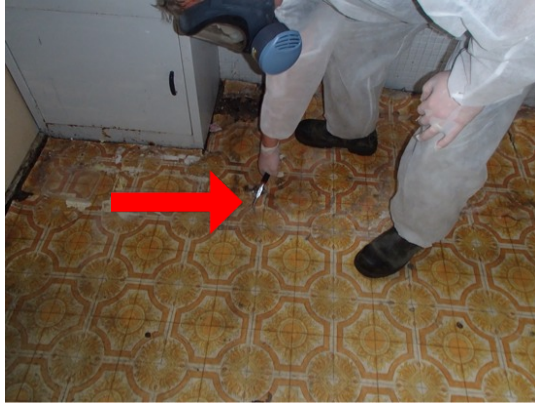
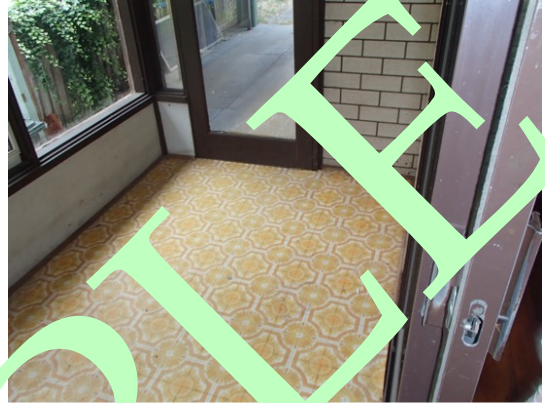
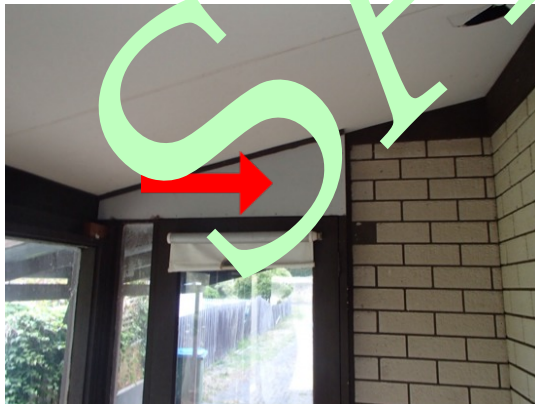
Asbestos, Asbestos Containing Materials and Asbestos Dust 4.09

Building:	Main Building
Location:	Sunroom
Finding:	Asbestos - ACM containing walls to sunroom, internally and externally
Information:	Samples of suspected Asbestos Containing Material (ACM) were removed from the building for analysis by a NATA accredited laboratory. The sample results confirmed that the material/s tested do contain Asbestos. The results indicated that the type of Asbestos is White Chrysotile. Consequently the client is advised to consider relevant risk reduction strategies including removal by a licensed Asbestos Removal firm.

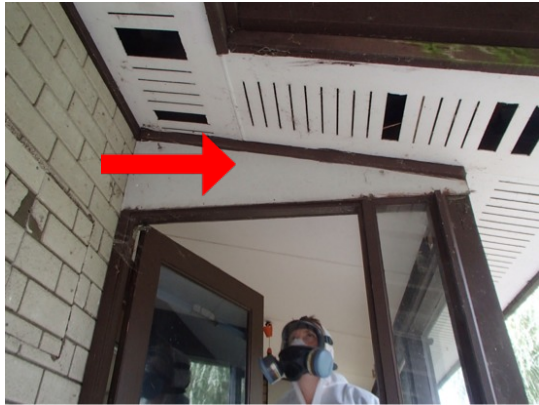
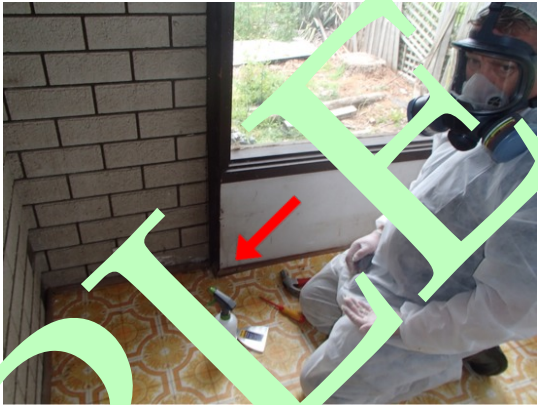
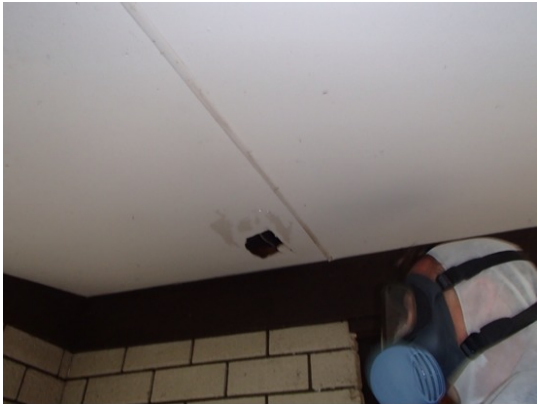
Asbestos, Asbestos Containing Materials and Asbestos Dust 4.1

Building: Main Building
Location: Sunroom
Finding: Asbestos - ACM Ceiling
Information: Samples of suspected Asbestos Containing Material (ACM) were removed from the building for analysis by a NATA accredited laboratory. The sample results confirmed that the material/s tested do contain Asbestos. The results indicated that the type of Asbestos is White Chrysotile. Consequently the client is advised to consider relevant risk reduction strategies including removal by a licensed Asbestos Removal firm.

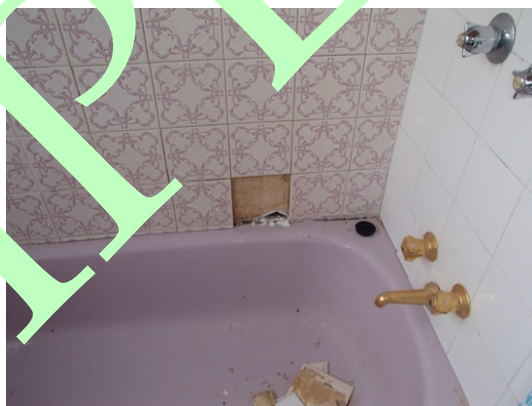
Asbestos, Asbestos Containing Materials and Asbestos Dust 4.11

Building: Main Building
 Location: Bathroom
 Finding: Asbestos - ACM Confirmed - sheeting behind tiles
 Information: Samples of suspected Asbestos Containing Material (ACM) were removed from the building for analysis by a NATA accredited laboratory. The sample results confirmed that the material/s tested do contain Asbestos. The results indicated that the type of Asbestos is white Chrysotile. Consequently the client is advised to consider relevant risk reduction strategies including removal by a licensed Asbestos Removal firm.

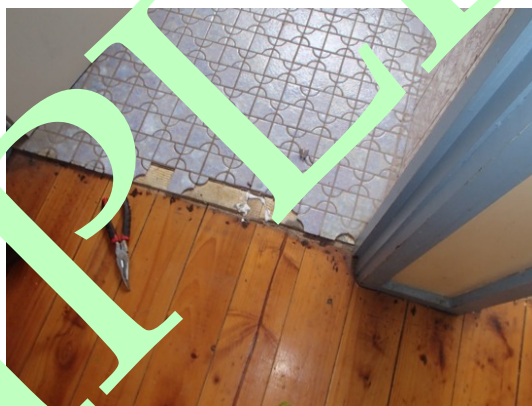
Asbestos, Asbestos Containing Materials and Asbestos Dust 4.12

Building: Main Building
 Location: Toilet (WC)

Finding:	Asbestos - ACM Confirmed - under floor tiles in toilet
Information:	Samples of suspected Asbestos Containing Material (ACM) were removed from the building for analysis by a NATA accredited laboratory. The sample results confirmed that the material/s tested do contain Asbestos. The results indicated that the type of asbestos is White Chrysotile. Consequently the client is advised to consider relevant risk reduction strategies including removal by a licensed Asbestos Removal firm.

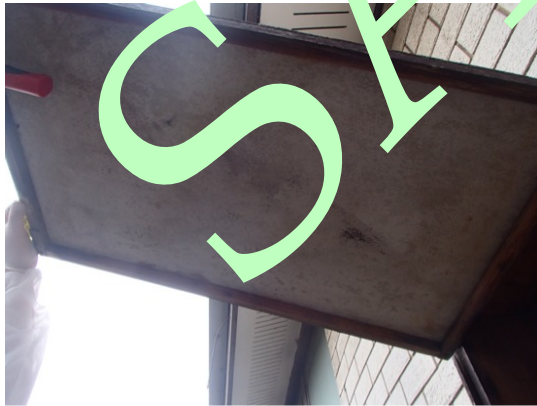
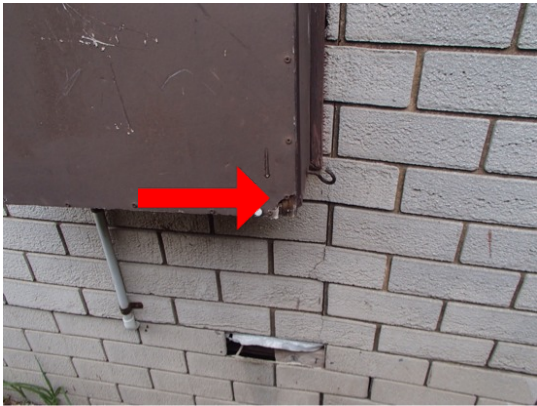
Building: Main Building
Location: Exterior walls - left
Finding: Asbestos - Negative Lab Result on fibre board door
Information: Samples of suspected Asbestos Containing Material (ACM) were removed from the building for analysis by a NATA accredited laboratory.

The samples analysed were free of Asbestos fibres.

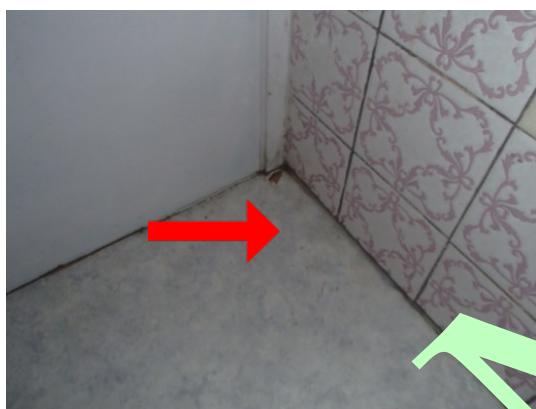
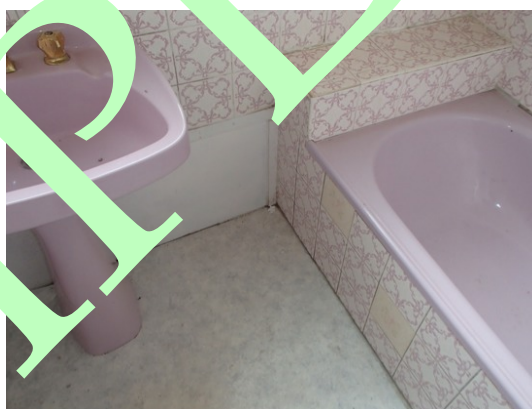
Building: Main Building
Location: Bathroom
Finding: Asbestos - Negative Lab Result - Vinyl floor
Information: Samples of suspected Asbestos Containing Material (ACM) were removed from the building for analysis by a NATA accredited laboratory.

The samples analysed were free of Asbestos fibres.
